Dekalb County School District (409-36) - Druid Hills High School Modernization Civil Site Assessment

Prepared by Cody Lanman Jan 31, 2024

Druid Hills Highschool Modernization Assessment, Preliminary Civil Site Investigation & observations. The following report documents the existing conditions of the DHHS Campus as it relates to the civil / site considerations.

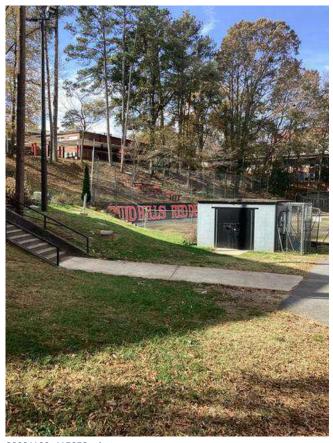
Existing concrete sidewalks, stairs, & wall experiencing cracking and staining. Condition varies in areas ranging from good / fair / poor conditions.

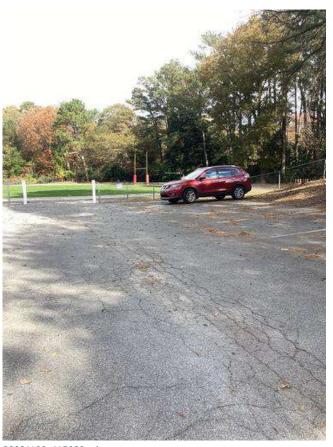
Asphalt pavement and curb in gutter conditions experiencing cracking & settling, appear to be in fair / poor condition.

Striping is faded or missing in areas.

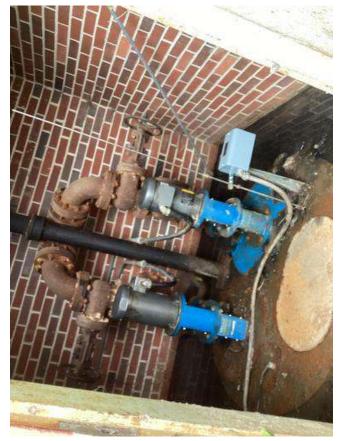
1961 Lift Station Building, pump & well. System appears to be leaking & in poor condition (Owner notified day of regarding conditions).

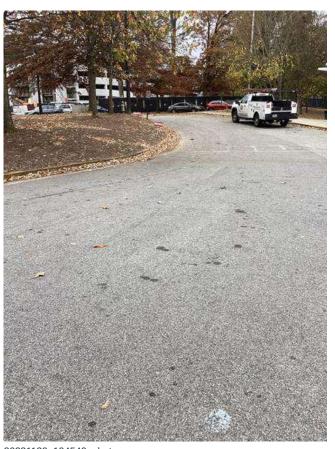
Asphalt pavement and curb in gutter conditions experiencing some cracking & settling. Conditions vary ranging from good, fair and poor in areas.

Sidewalks experiencing cracking and chipping, appear in good / fair condition.

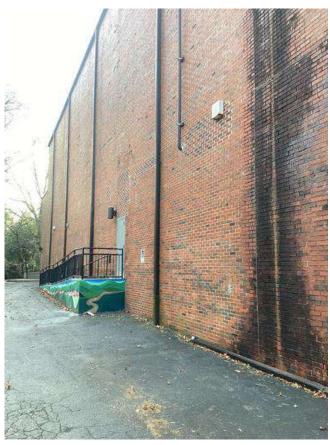
Existing stairs and handrails to gymnasium are damaged & chipped.

Documentation of existing downspout locations, several boot connections appear to be missing and in poor condition.

Asphalt pavement cracking & settling, appear to be in fair / poor condition.

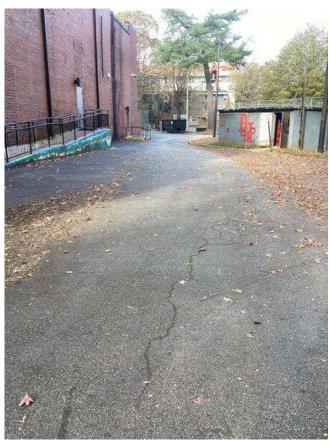
Documentation of existing downspout locations, several boot connections appear to be in poor condition.

Asphalt pavement cracking & settling, appear to be in fair / poor condition. Asphalt patch / repair locations appear in poor condition and experiencing pumping causing low points along top of retaining wall.

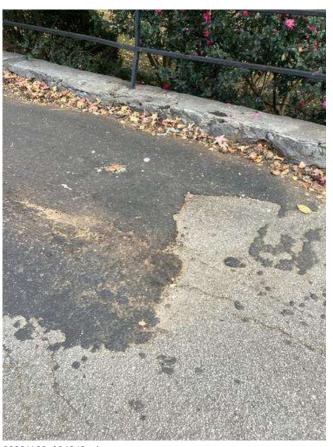
Pavement surrounding drop inlet damaged and is not flush with grate cover. Inlet and structure appear to be full of trash and debris.

Asphalt pavement and curb in gutter conditions experiencing cracking & settling, appear to be in fair / poor condition.

Driveway width does not appear to adhere to recommended layout or adhere to aerial apparatus fire code requirements.

Existing retaining wall and handrails are damaged. Note: Majority of access drive and wall are over property line, encroachment is identified on existing easement agreements with adjacent property owner.

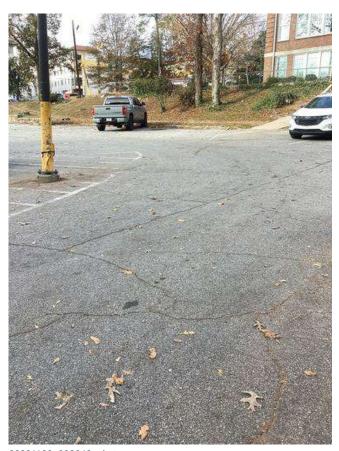
Asphalt pavement and curb in gutter conditions experiencing cracking & settling, appear to be in fair / poor condition.

Lot layout and dimensions do not appear to adhere to recommended layout or code requirements.

Striping is faded or missing in areas.

Existing light pole base appears damaged.
