# FACILITY CONDITION ASSESSMENT

*Marbut Elementary School | 2021*

DeKalb County SD - Marbut Elementary School

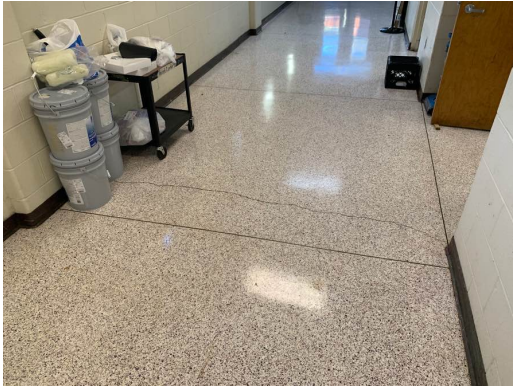
Cracked Terrazzo In Corridor

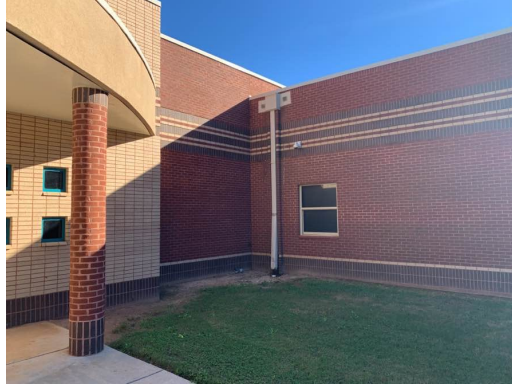
Downspout Damaged

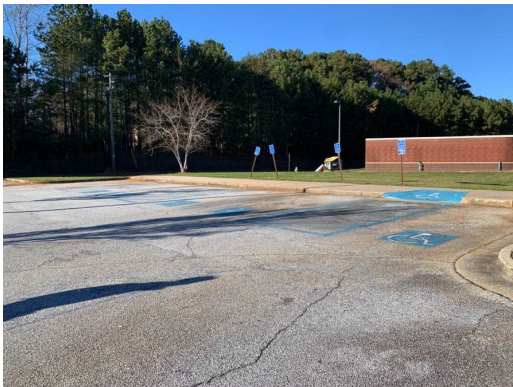
Restripe ADA Parking Spaces

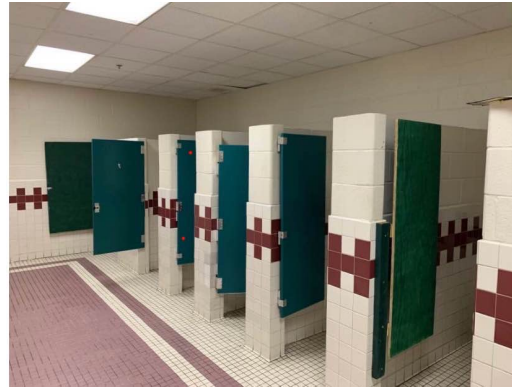
Deficiency	Category	Qty	UoM	Priority	Repair Cost	ID
Toilet Partition Replacement <b>Note:</b> Toilet Partitions Throughout Facility Are Damaged, Many Of Them Are Constructed Of Painted Plywood	Capital Renewal	6	Stall	4	\$11,375	4183
<b>Sub Total for System</b>		<b>1</b>	<b>items</b>		<b>\$11,375</b>

Partitions

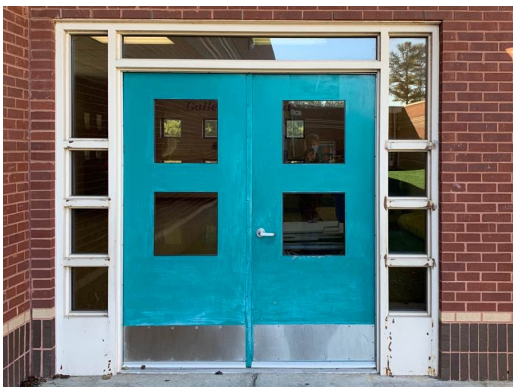
Exterior Storefront Frames Are Rusted

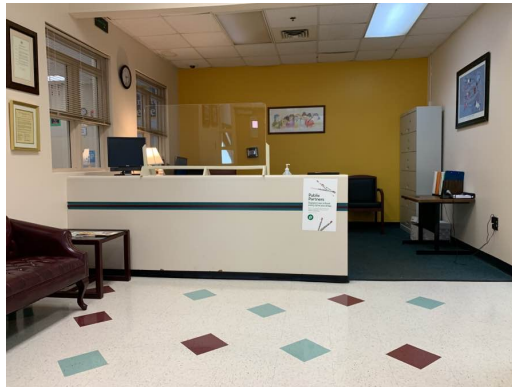
Deficiency	Category	Qty	UoM	Priority	Repair Cost	ID
Counter Heights Exceed Maximum ADA Height Requirements (Modify Full) <b>Note:</b> Room 61 - Reception - No ADA Count	ADA Compliance	5	LF	3	\$2,457	392
<b>Sub Total for System</b>		<b>1</b>	<b>items</b>		<b>\$2,457</b>	
<b>Sub Total for Building 2010 - Building 2010</b>		<b>45</b>	<b>items</b>		<b>\$5,152,257</b>

Counter Does Not Meet ADA Requirements
