Revision Date - 09/24/2021

FACILITY CONDITION ASSESSMENT

Tucker High School | 2021

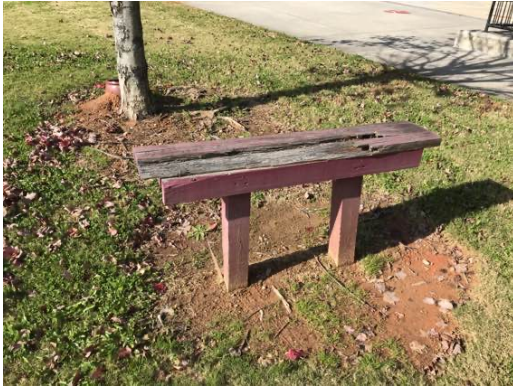
Replace Benches

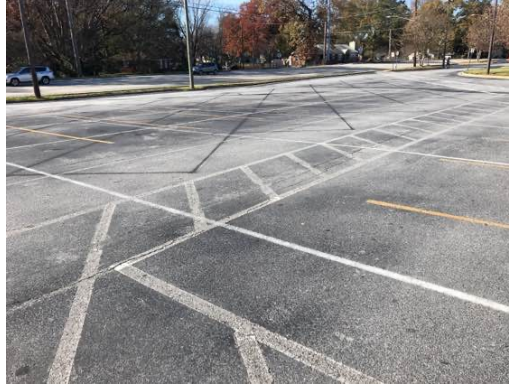
Restripe West Parking Lot

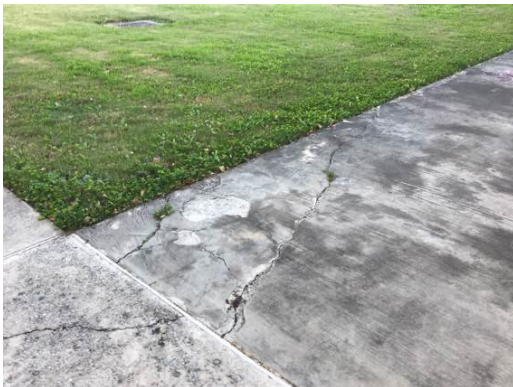
Replace Sidewalk

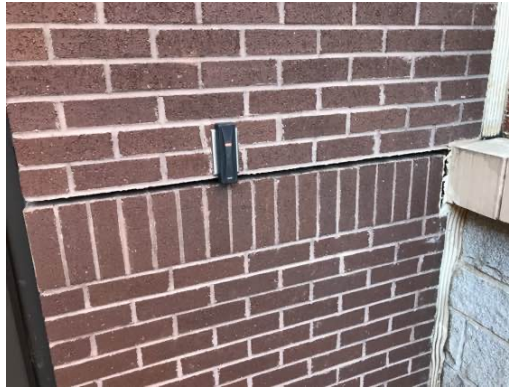
Repoint Brick Mortar

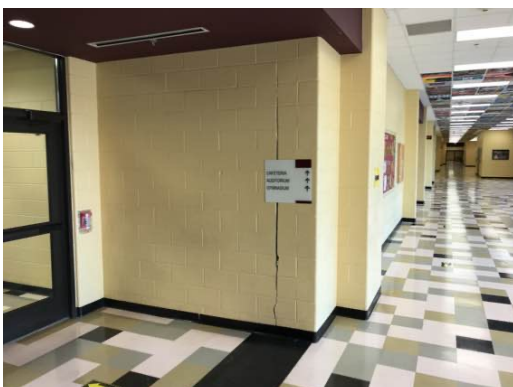
Repair Slab Settlement And CMU Wall Cracks

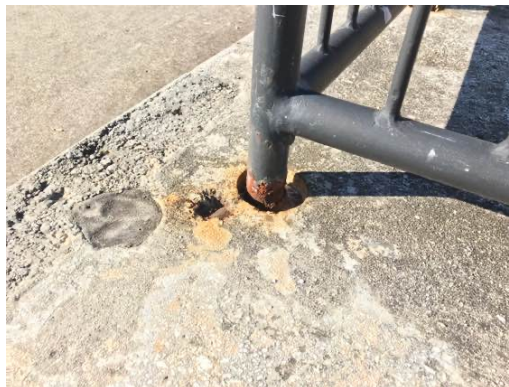
Repaint Parking Deck Handrail. Caulk Post Pockets To Prevent Holding Water And Rust
