FACILITY CONDITION ASSESSMENT

Redan Middle School | 2021

DeKalb County SD - Redan Middle School

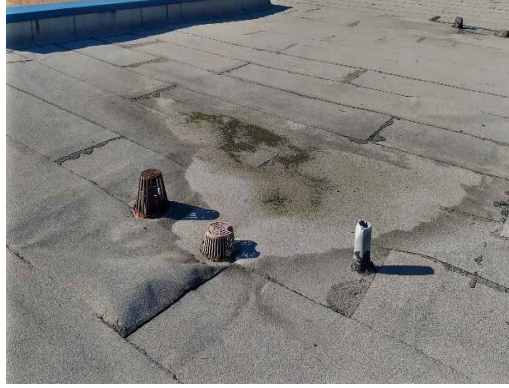
Roof Deficiency Conditions

| Deficiency | Category | Qty | UoM | Priority | Repair Cost | ID |
|---|---|---|---|---|---|---|
| Modified Roof Covering Replacement Note: Extreme Blisters And Deterioration | Capital Renewal | 154,513 | SF | 2 | \$5,006,792 | 929 |

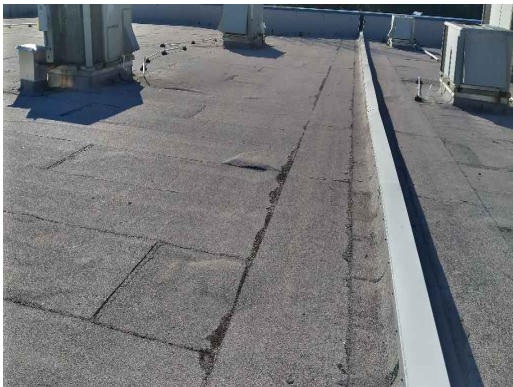
Roof Major Blisters

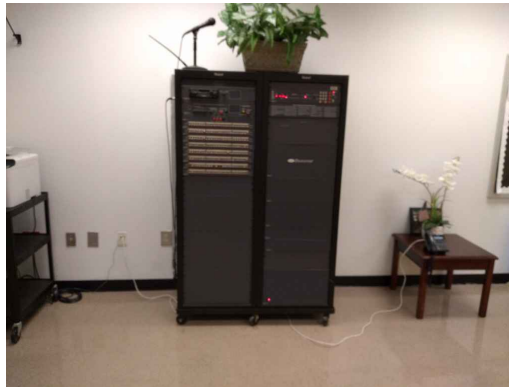
Security System Is 20 Years Old

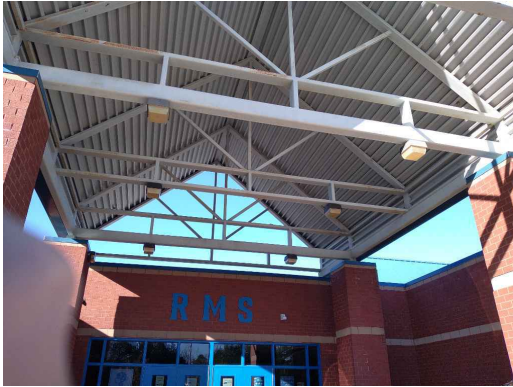
Only One Canopy Light Is Working

| Deficiency | Category | Qty | UoM | Priority | Repair Cost | ID |
|---|---|---|---|---|---|---|
| Canopy Lighting Replacement Note: Some Work Orders Have Been Submitted For Canopy Lights Replacement Location: Multiple Locations | Capital Renewal | 5 | Ea. | 3 | \$9,792 | 526 |
