# FACILITY CONDITION ASSESSMENT

*Toney Elementary School | 2021*

Toney Elementary School is located at 2701 Oakland Terrace in Decatur, GA. It comprises 64,983 gross square feet. At the time of the assessment the oldest building was 67 years old.

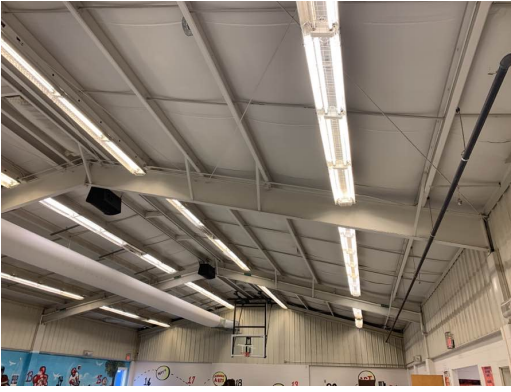
Existing T8 Fluorescent Lamps Are Beyond Useful Life

| Deficiency | Category | Qty | UoM | Priority | Repair Cost | ID |
|---|---|---|---|---|---|---|
| Lighting Fixtures Replacement<br><b>Note:</b> Old T8 Lamps | Capital Renewal | 39,500 | SF | 3 | \$681,032 | 9591 |

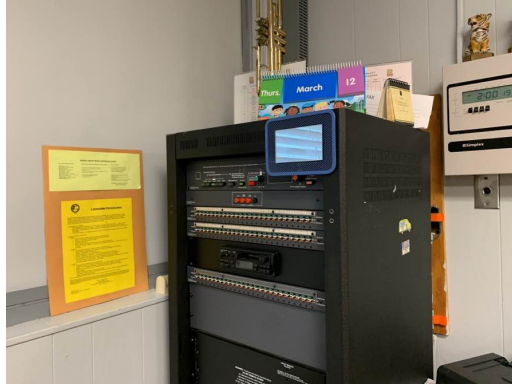
The Existing Intercom System Is Beyond Useful Life

| Deficiency | Category | Qty | UoM | Priority | Repair Cost | ID |
|---|---|---|---|---|---|---|
| Public Address System Replacement, Non-main Building<br><b>Note:</b> Beyond Useful Life | Deferred Maintenance | 39,500 | SF | 3 | \$26,288 | 9566 |

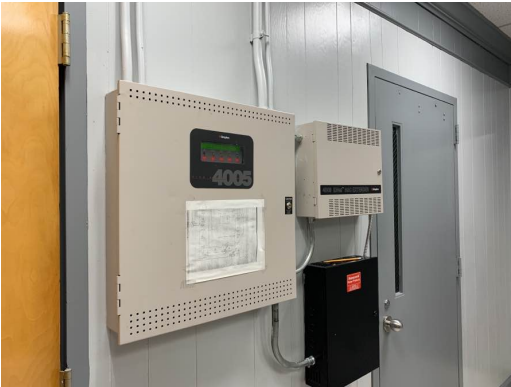
Existing Fire Alarm System Is Beyond Useful Life

| Deficiency | Category | Qty | UoM | Priority | Repair Cost | ID |
|--|---|---|---|---|---|---|
| Fire Alarm Replacement<br><b>Note:</b> Beyond Useful Life | Capital Renewal | 39,500 | SF | 1 | \$217,178 | 9585 |

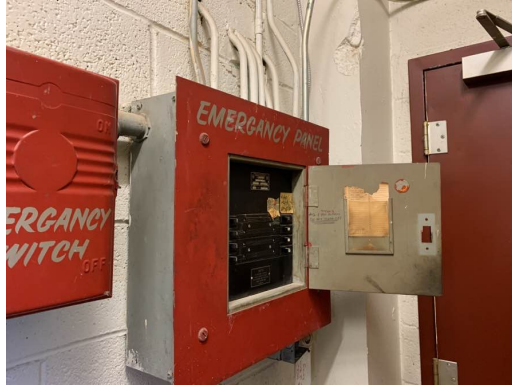
Existing Emergency Panel In Storage 17 Needs To Be Replaced

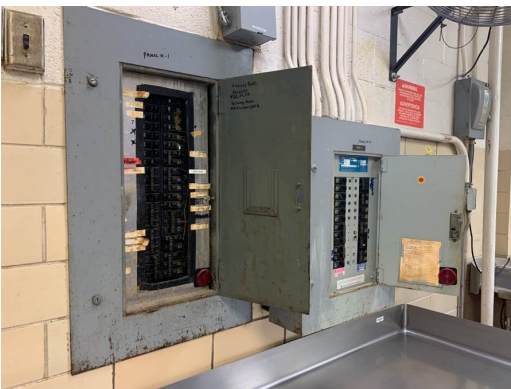
Electrical Panels In Kitchen Are Beyond Their Useful Life. Exposed Bus Inside Panel And No Lock On The First Kitchen Panel

| Deficiency | Category | Qty | UoM | Priority | Repair Cost | ID |
|---|---|---|---|---|---|---|
| Panelboard Replacement<br><b>Note:</b> 200A, Beyond Useful Life - Kitchen | Capital Renewal | 1 | Ea. | 2 | \$5,170 | 9589 |
| Panelboard Replacement<br><b>Note:</b> Beyond Useful Life - Kitchen | Capital Renewal | 1 | Ea. | 2 | \$2,616 | 9590 |

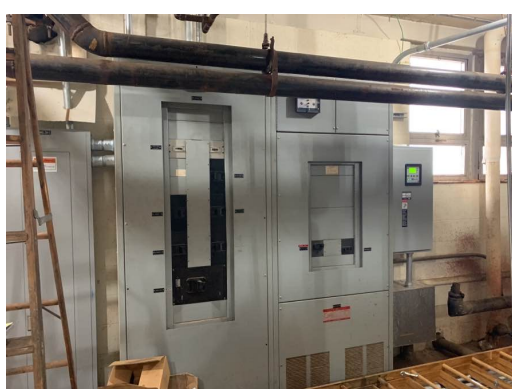
Main Switchboard In Mechanical Room 36.1 Is Beyond Its Useful Life. Photo Should Be In Building 2012

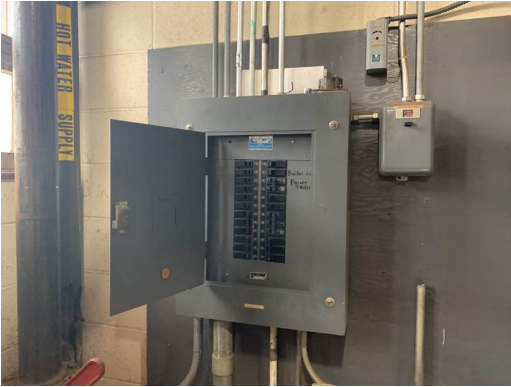
Electrical Panel In Mechanical Room 36.1 Is Beyond Its Useful Life. Photo Should Be In Building 2012

| Deficiency | Category | Qty | UoM | Priority | Repair Cost | ID |
|---|---|---|---|---|---|---|
| Panelboard Replacement<br><b>Note:</b> Mech 36.1 | Capital Renewal | 1 | Ea. | 2 | \$6,288 | 9645 |
| Panelboard Replacement<br><b>Note:</b> Mech 36.1 | Capital Renewal | 1 | Ea. | 2 | \$5,170 | 9646 |

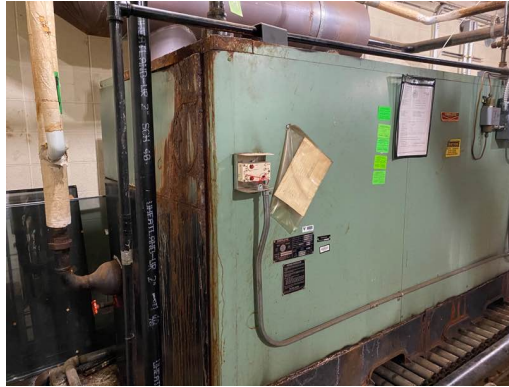
2012- Mech 36.1- Replace Boiler

| Deficiency | Category | Qty | UoM | Priority | Repair Cost | ID |
|--|---|---|---|---|---|---|
| Boiler Replacement<br><b>Note:</b> Mech 36.1 | Capital Renewal | 1 | Ea. | 2 | \$105,715 | 9632 |

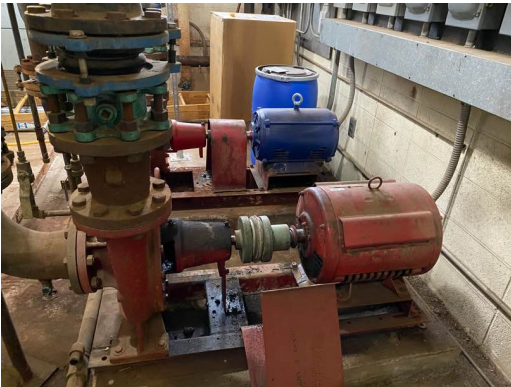
2012- Mech 36.1- Replace Loop Pumps

| Deficiency | Category | Qty | UoM | Priority | Repair Cost | ID |
|--|---|---|---|---|---|---|
| Circulation Pump Replacement<br><b>Note:</b> Mech 36.1 | Capital Renewal | 1 | Ea. | 3 | \$10,869 | 9641 |
| Circulation Pump Replacement<br><b>Note:</b> Mech 36.1 | Capital Renewal | 2 | Ea. | 3 | \$27,042 | 9642 |

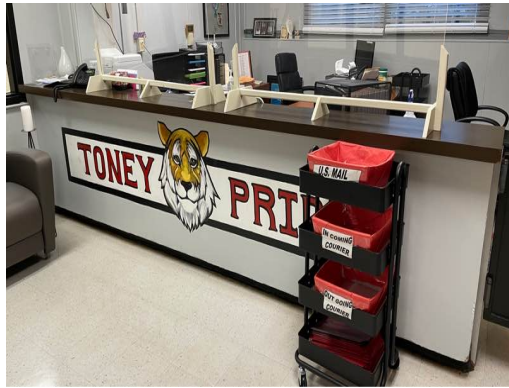
Main Office Counter It Is Non-ADA Compliant. Counter Needs To Be Retrofitted To Provide ADA Accessibility

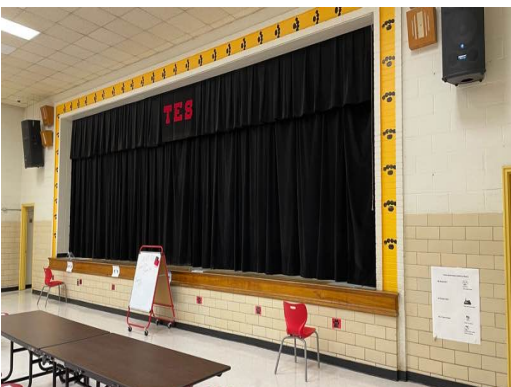
Stage Access Is Non-ADA Compliant And A Lift Is Needed To Provide ADA Accessibility

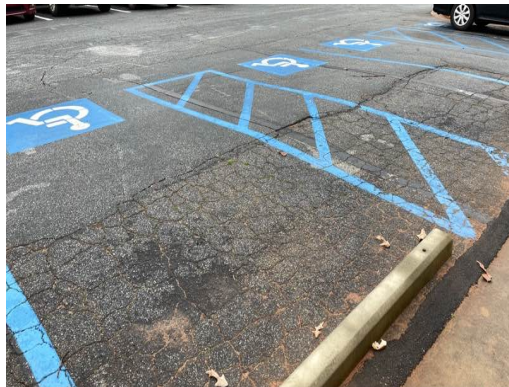
Asphalt Parking Area Is Cracked And Beyond Useful Life Needs To Be Repaved

| Deficiency | Category | Qty | UoM | Priority | Repair Cost | ID |
|---|---|---|---|---|---|---|
| Asphalt Driveway Replacement<br><b>Note:</b> Beyond Useful Life | Capital Renewal | 14,400 | SF | 3 | \$87,058 | 9521 |

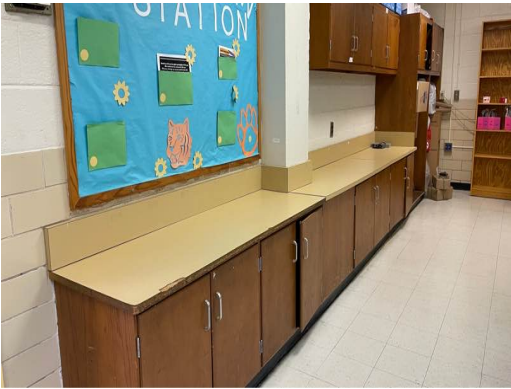
Cabinetry Is Beyond Useful Life And Needs To Be Replaced

| Deficiency | Category | Qty | UoM | Priority | Repair Cost | ID |
|--|---|---|---|---|---|---|
| Replace Cabinetry In Classes/Labs<br><b>Note:</b> Beyond Useful Life | Capital Renewal | 12 | Room | 4 | \$99,303 | 9546 |

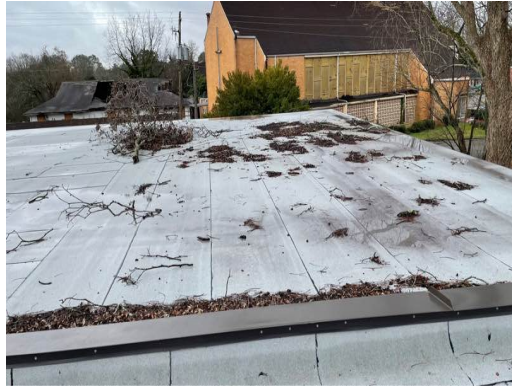
Roof Debris Needs To Be Cleared
