**Re: Lead in Drinking Water Sample Results
AIC Facility and DECA and Elizabeth Andrews High Schools (#0109)
1701 Mountain Industrial Blvd, Stone Mountain, GA 30083
AEM Project No. 1561-1601**

**Table 1. Summary of Lead in Drinking Water Laboratory Analytical Results
AIC Facility and DECA/Elizabeth Andrews High Schools
1701 Mountain Industrial Blvd., Stone Mountain, GA 30083**

**Re: Final Lead in Drinking Water Sample Results
AIC Bus Fleet Facility (#0109)
1701 Mountain Industrial Blvd, Stone Mountain, Georgia 30083
AEM Project No. 1561-1601**

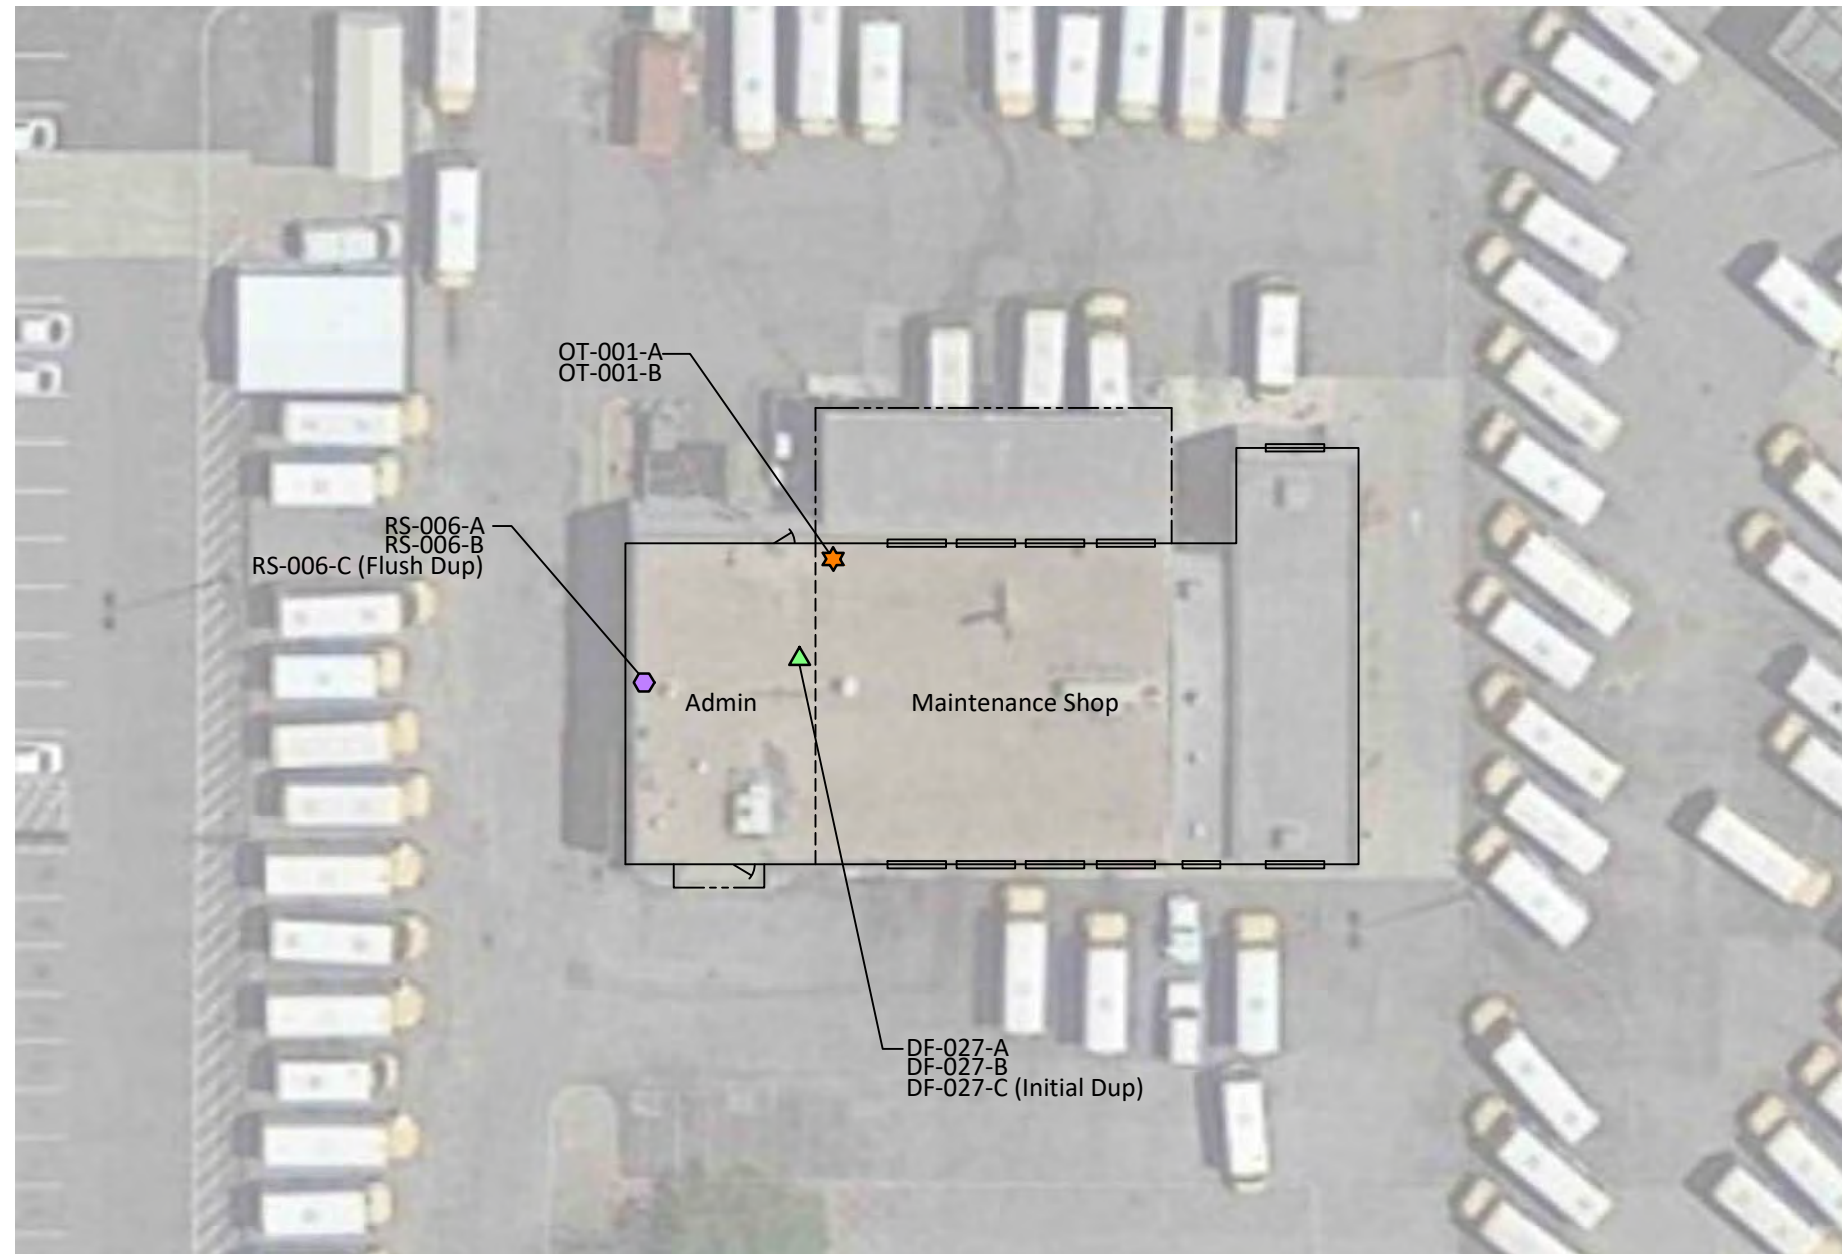
AEM collected eight drinking water samples from three sources at the AIC Bus Fleet Facility (Facility ID #0109), including two duplicate samples. Figure 1 depicts the source sample locations. Samples were collected in accordance with the Water Sampling Methodology Protocol for DeKalb County School District, dated September 12, 2016. A copy of AEM's Field Sampling Notes is provided in Attachment A.

- ▲ - Drinking Fountain (DF)
- ★ - Other (OT)
- - Restroom Sink (RS)
