Dekalb County School District (409-36) - Druid Hills High School Modernization Civil Site Assessment

Prepared by Cody Lanman Jan 31, 2024

Druid Hills Highschool Modernization Assessment, Preliminary Civil Site Investigation & observations. The following report documents the existing conditions of the DHHS Campus as it relates to the civil / site considerations.

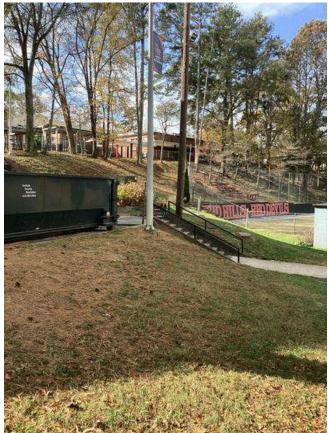
Existing concrete sidewalks, stairs, & wall experiencing cracking and staining. Condition varies in areas ranging from good / fair / poor conditions.

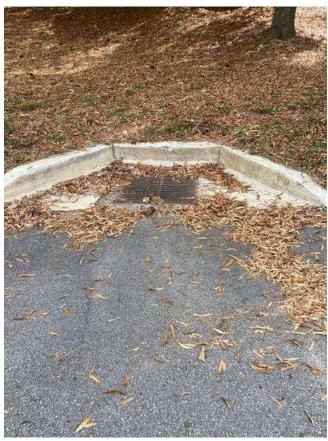
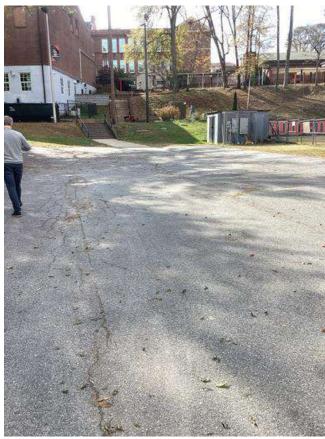
Asphalt pavement and curb in gutter conditions experiencing cracking & settling, appear to be in fair / poor condition.

Striping is faded or missing in areas.

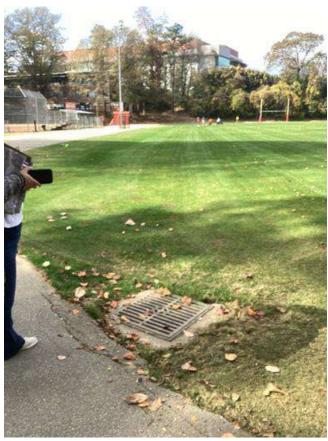
Portions of field are thin and in moderate condition. Track asphalt experiencing cracking and deviations in surface. Pavement appears to be in moderate to fair condition.

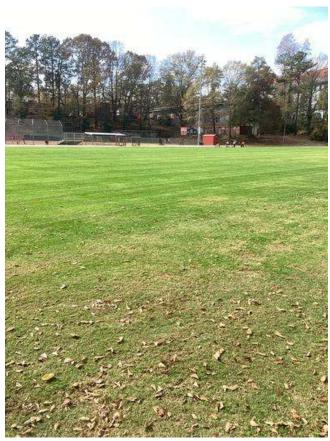
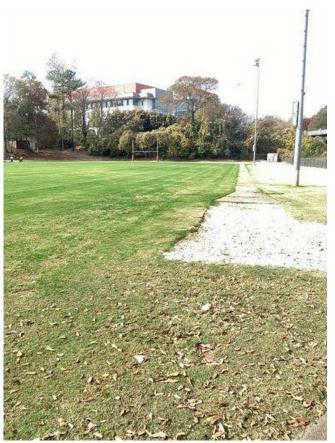
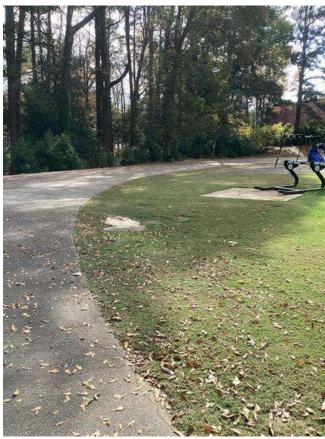
Portions of field are thin and in moderate condition. Track asphalt experiencing cracking and deviations in surface. Pavement appears to be in moderate to fair condition.

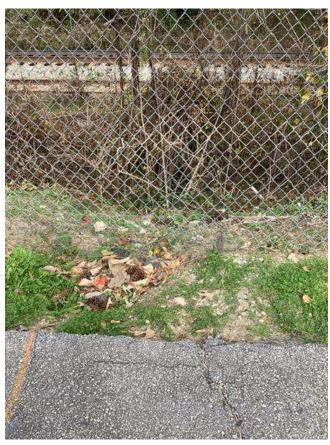
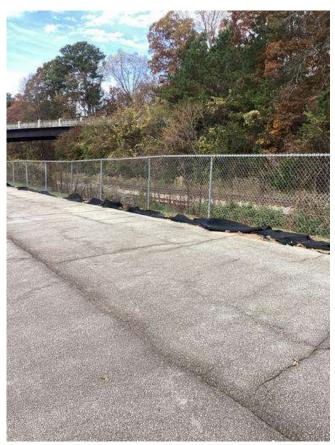
Track asphalt experiencing cracking and deviations in surface. Pavement appears to be in moderate to fair condition.

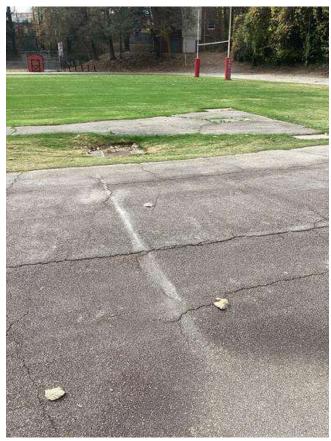
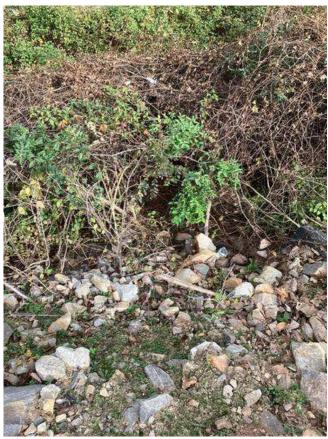
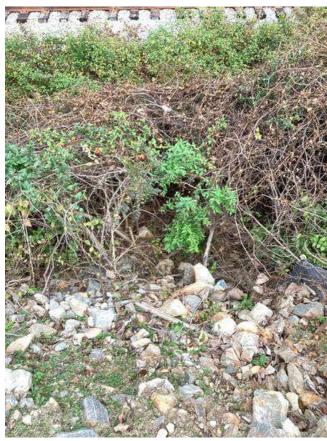
Portions of field are thin and in moderate condition. Track asphalt experiencing cracking and deviations in surface. Pavement appears to be in moderate to fair condition.

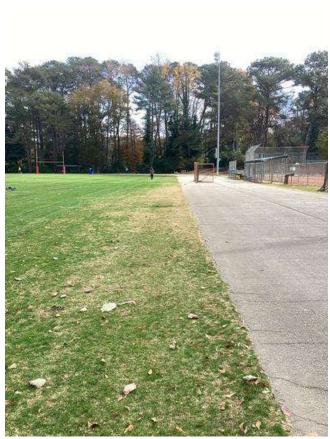
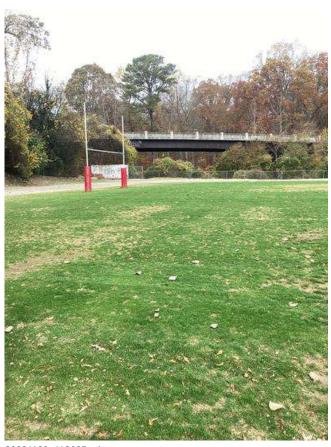
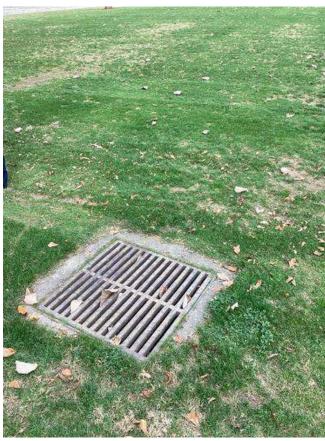
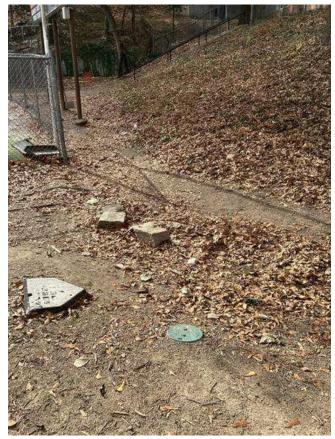
Portions of field are thin and in moderate condition. Track asphalt experiencing cracking and deviations in surface. Pavement appears to be in moderate to fair condition.

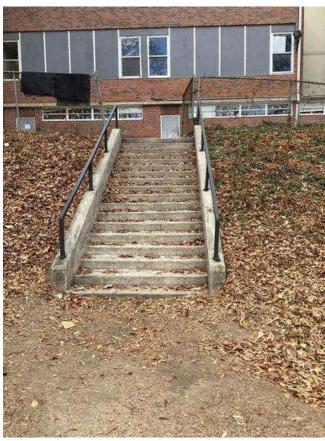
Existing sidewalk and stairs experiencing cracking and appear to be in moderate / poor condition. Stair handrails do not appear to adhere to standard configuration.

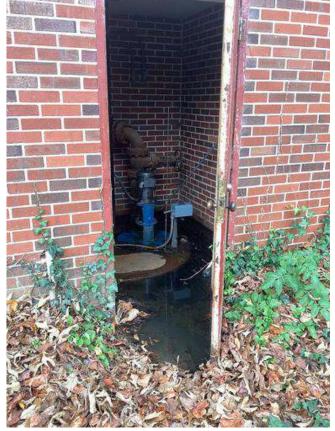
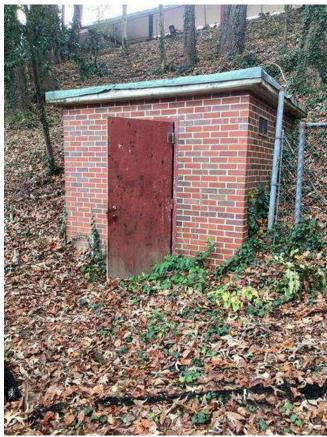
1961 Lift Station Building, pump & well. System appears to be leaking & in poor condition (Owner notified day of regarding conditions).

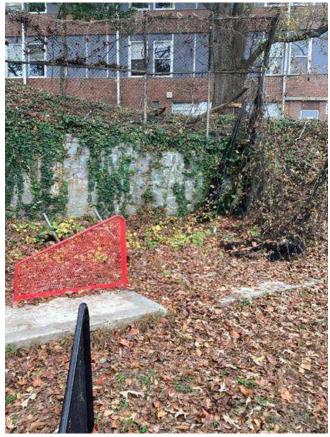
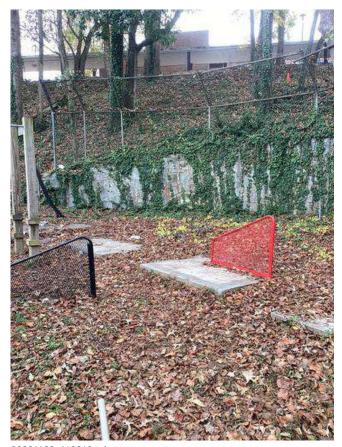
Existing stone wall appears in relatively good / fair condition. Significantly overgrown with vines & vegetation in areas.

Fencing along top of wall in poor condition.

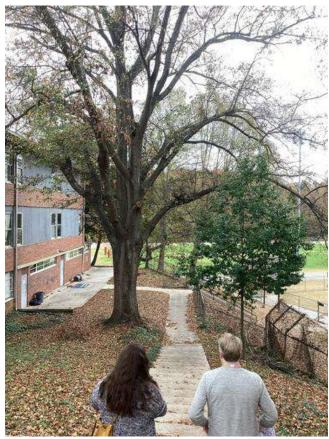
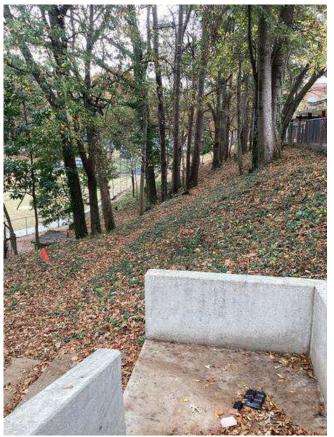
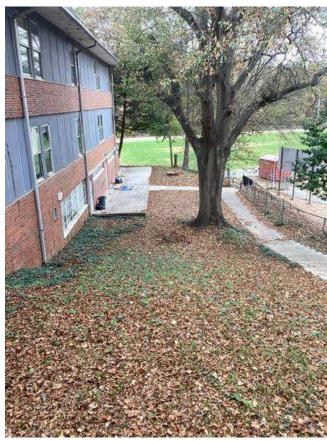
Existing concrete sidewalks, stairs, & wall experiencing cracking and staining.
Condition varies in areas ranging from good / fair / poor conditions.

Existing downspout boot connections in fair / poor conditions.

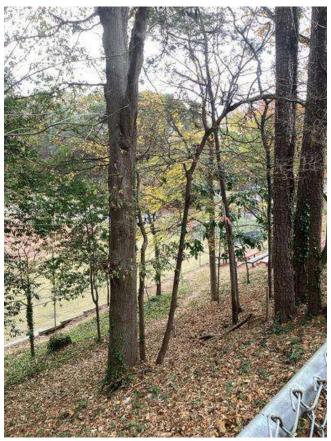
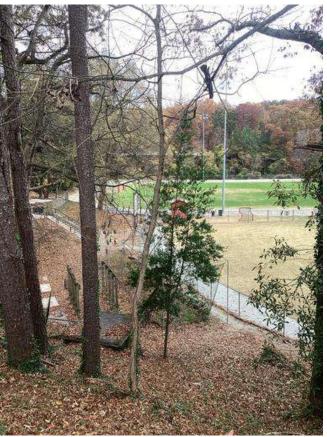
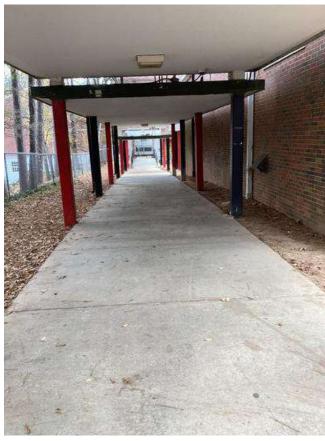
Existing concrete sidewalks, ramps, and walls experiencing cracking and staining. Condition varies in areas ranging from good / fair / poor conditions.

Existing canopy downspouts / boot connections in fair / poor conditions.

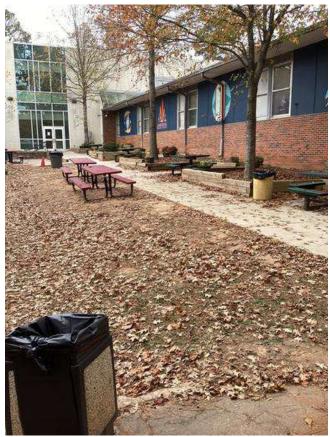
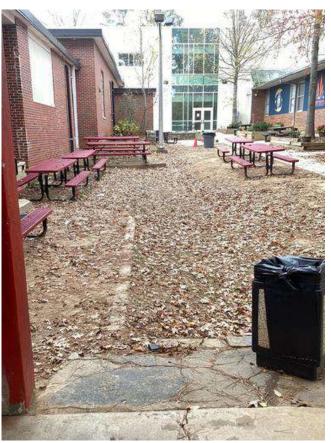
Existing concrete sidewalks, curbs and walls experiencing cracking and staining.

Condition varies in areas ranging from good / fair / poor conditions.

Existing downspout boot connections in fair / poor conditions.

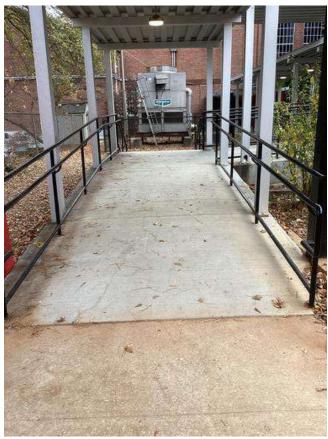
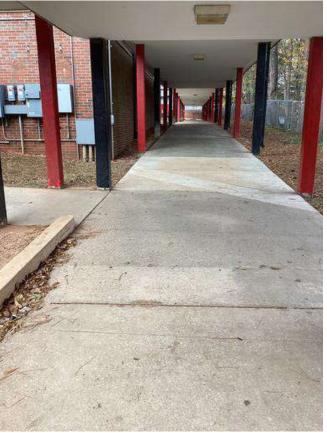
Existing concrete sidewalks, ramps, and walls experiencing cracking and staining. Condition varies in areas ranging from good / fair / poor conditions.

Existing canopy downspouts / boot connections in fair / poor conditions.

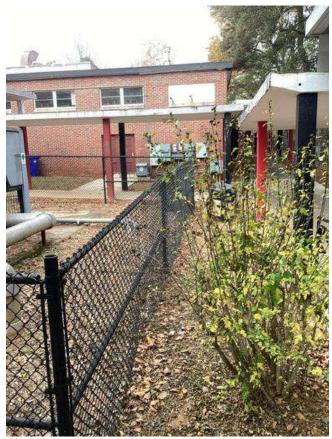
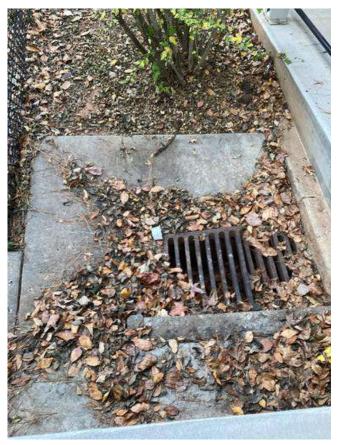
Existing downspout boot connections in fair / poor conditions.

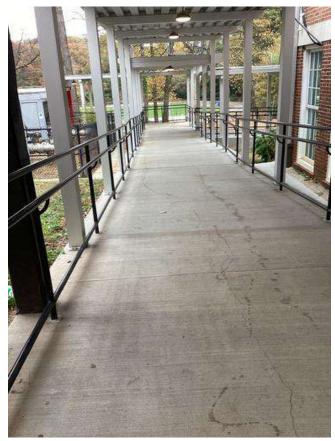
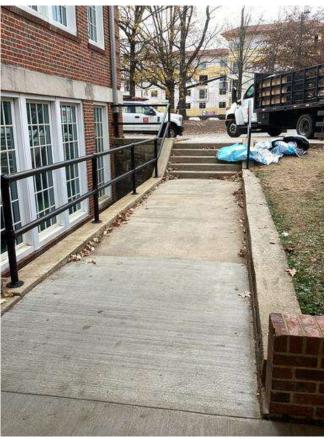
Existing concrete sidewalks & walls experiencing cracking and staining.
Condition varies in areas ranging from good / fair / poor conditions.

Downspout connections appear in fair condition.

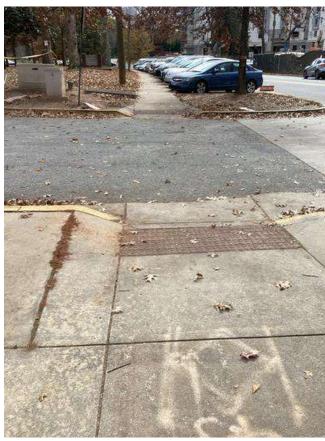
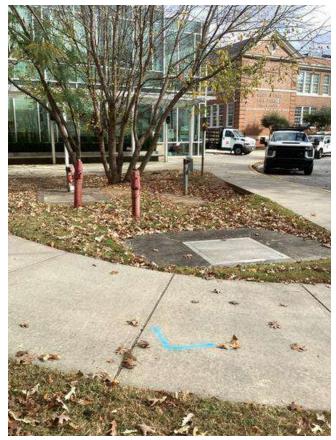
Asphalt driveway and curb in gutter conditions experiencing some cracking & settling, appear to be in good / fair condition.

Sidewalks experiencing some cracking and chipping, appear in fair condition.

Driveway configuration and connection to right-of-way not does not appear to adhere to standard recommendations and does not appear to meet code dimensions.

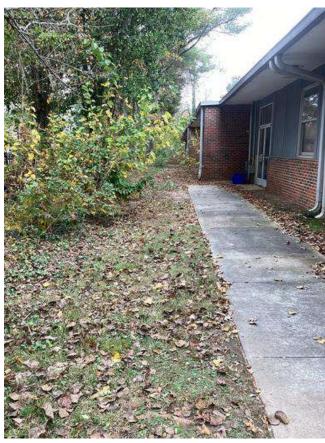
Existing downspouts missing energy dissipation. Washout and erosion occurring in areas.

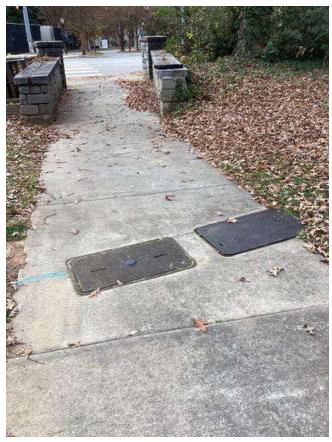
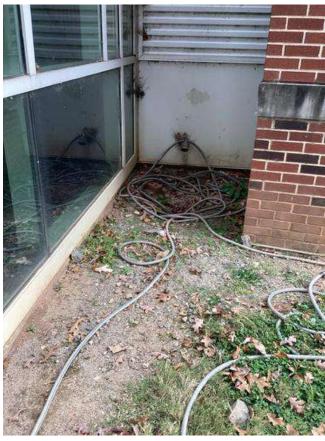
Sidewalks experiencing minor cracking but appear in generally good condition.

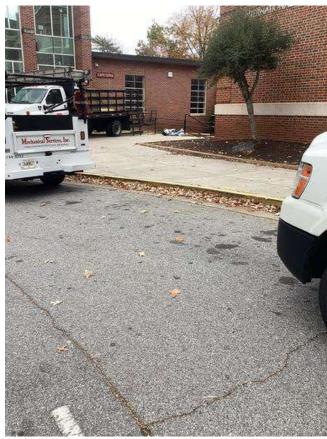
20231120_104548_photo **Cody Lanman** Nov 20, 2023 10:45 AM

Asphalt pavement and curb in gutter conditions experiencing some cracking & settling. Conditions vary ranging from good, fair and poor in areas.

Sidewalks experiencing cracking and chipping, appear in good / fair condition.

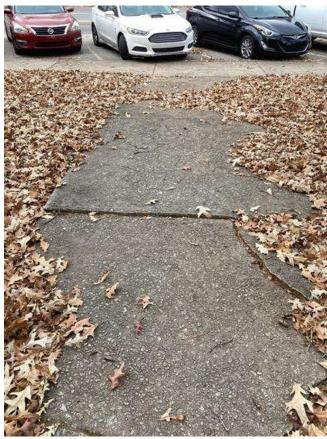
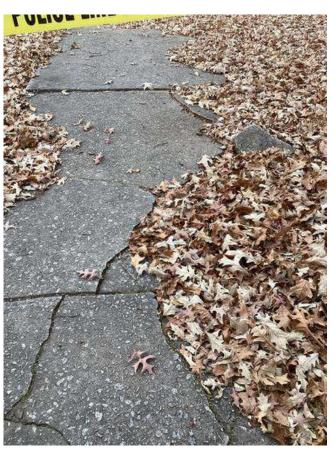
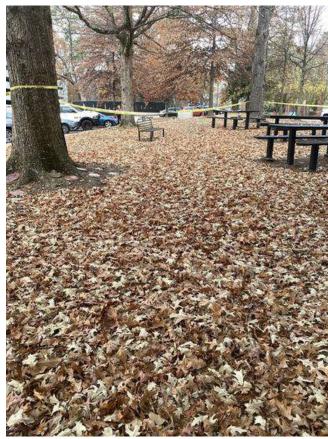
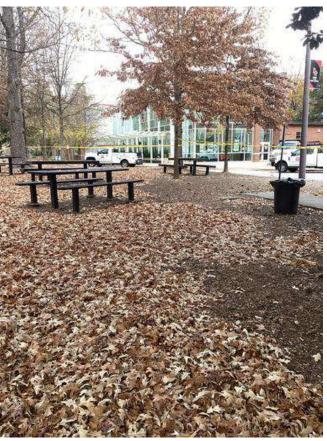
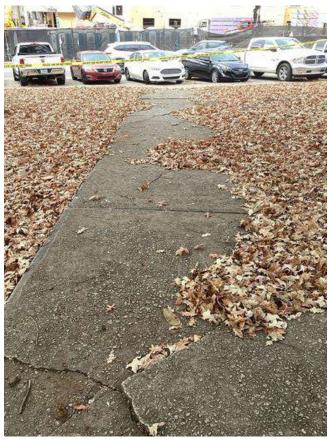
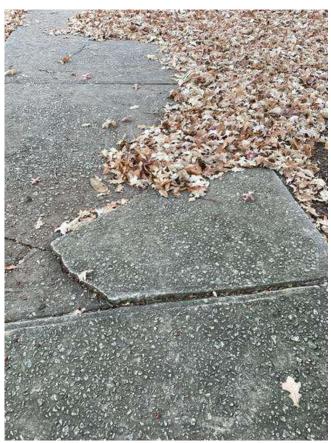
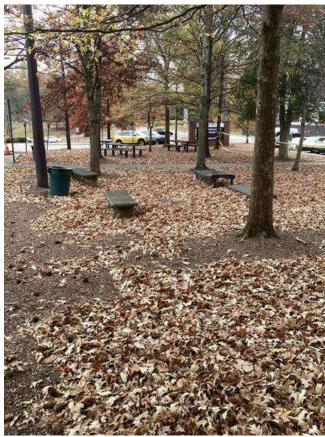
Sidewalks experiencing cracking and chipping, appear in good / fair condition.

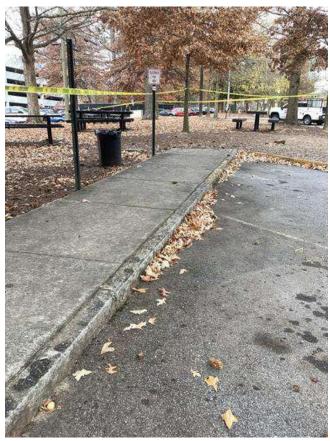
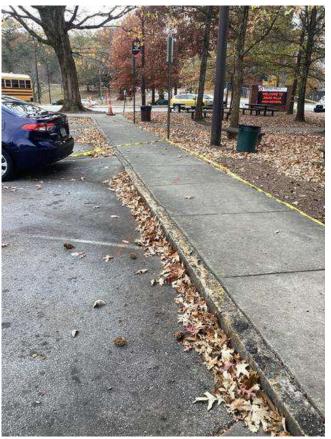
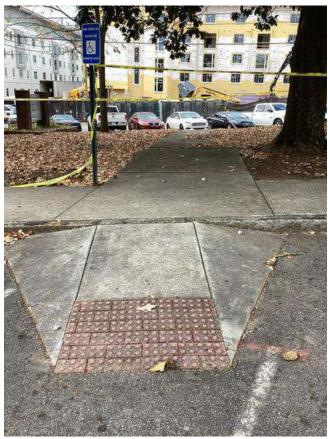
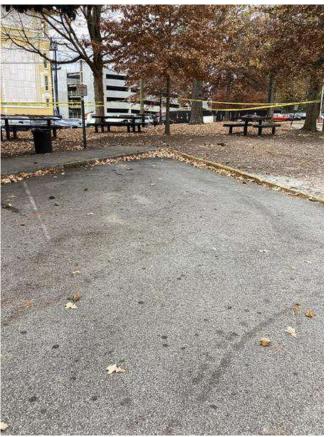
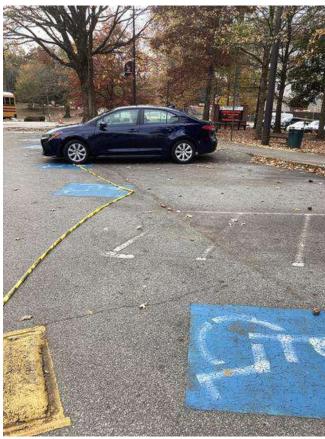
Asphalt pavement and curb in gutter conditions experiencing some cracking & settling. Conditions vary ranging from good, fair and poor in areas.

Sidewalks experiencing cracking and chipping, appear in good / fair condition.

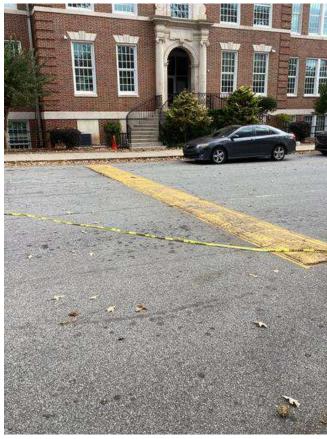
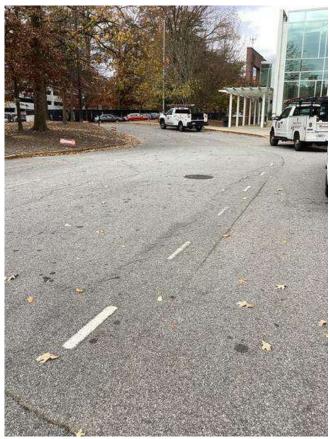
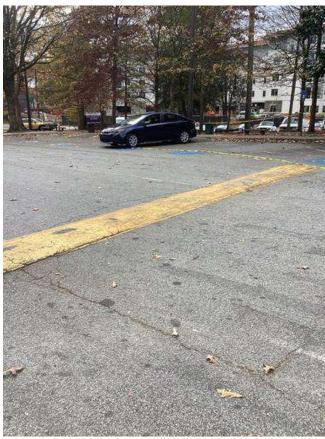
Asphalt pavement, Speed bumps and curb & gutter conditions experiencing some cracking & settling. Conditions vary ranging from good, fair and poor in areas.

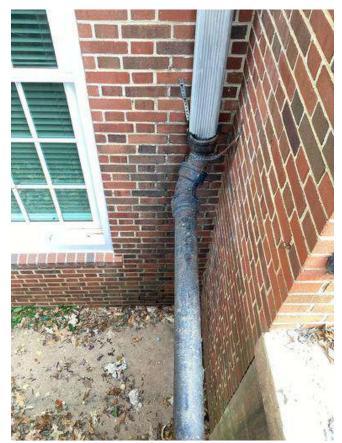
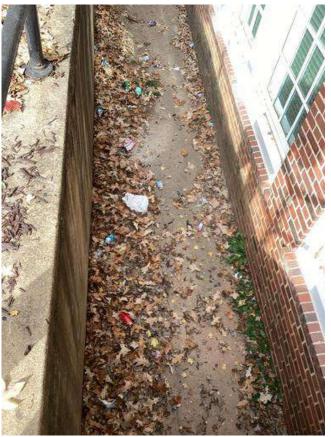
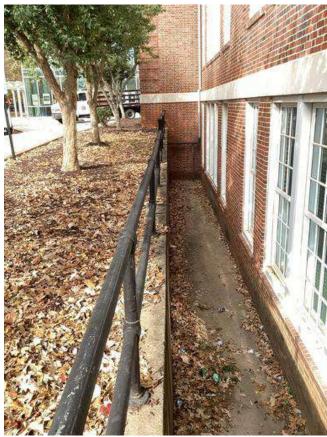
Downspout connections appear in fair condition.

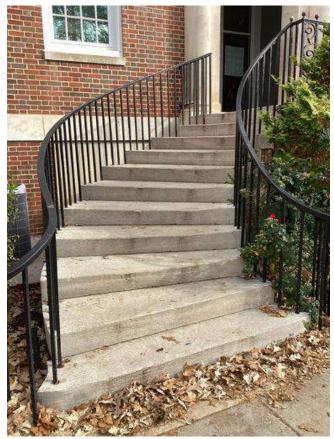
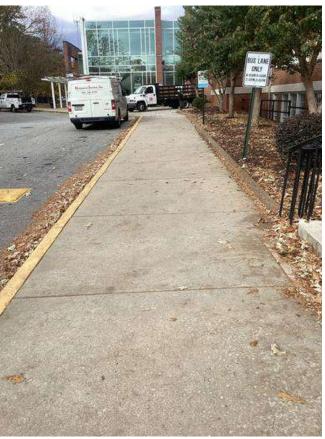
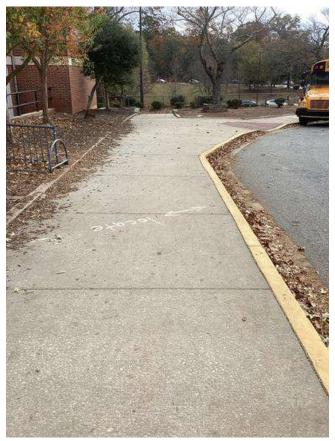
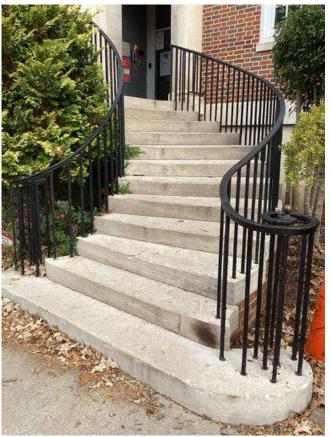
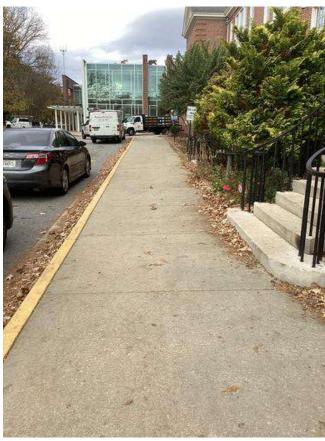
Sidewalks experiencing minor cracking and chipping, appear in generally good condition.

Main entrance stairs and railing appears in generally good condition.

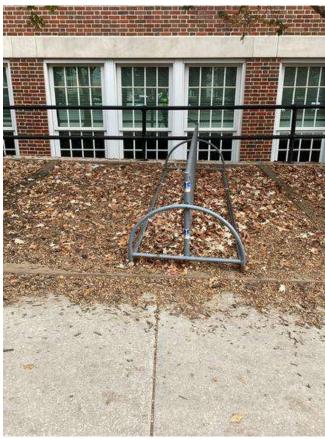
20231120_103959_photo **Cody Lanman** Nov 20, 2023 10:40 AM

Transitions to landscape areas in ranging conditions & not clearly defined causing mulch & vegetative debris to spill onto sidewalks.

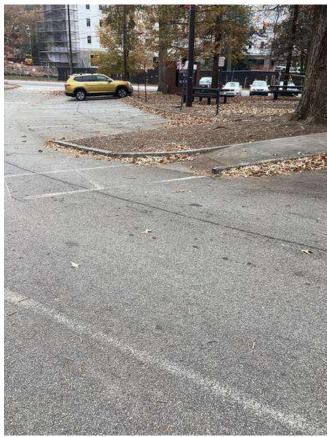
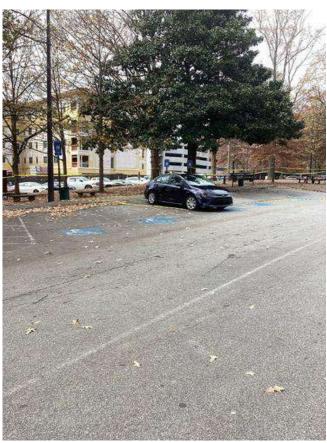
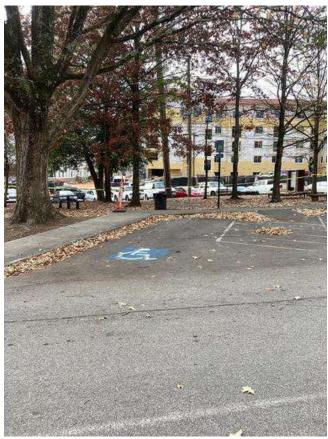
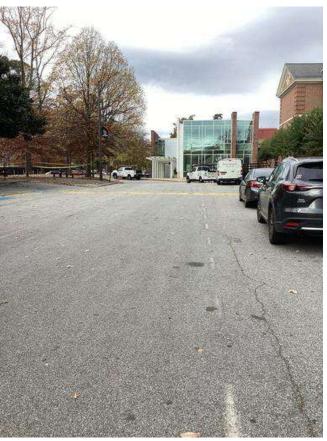
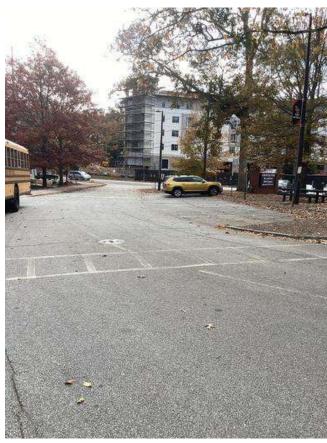
Asphalt pavement and curb in gutter conditions experiencing some cracking & settling. Conditions vary ranging from good, fair and poor in areas.

Sidewalks experiencing significant cracking and chipping, appear in fair condition.

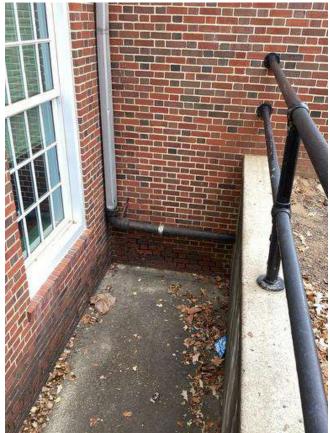
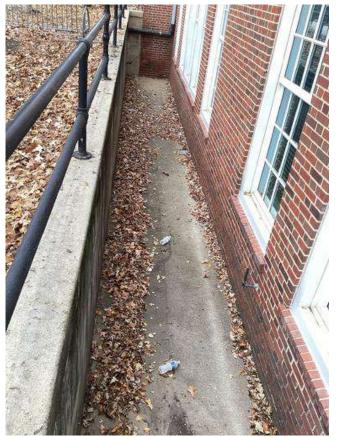
Downspout connections appear in fair condition.

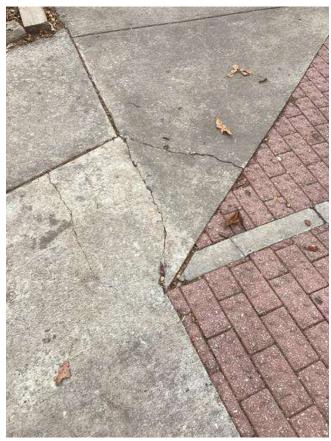
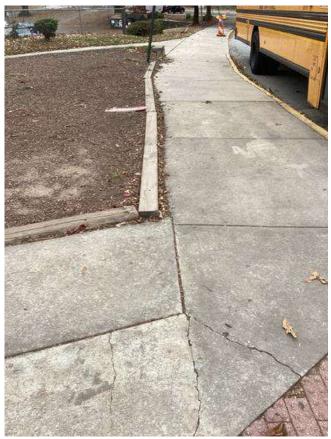
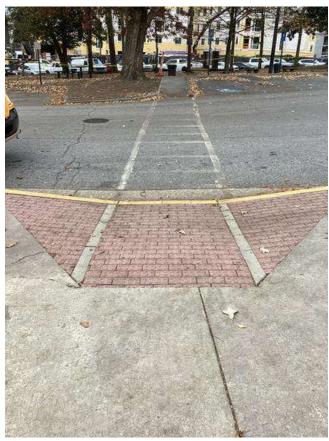
Asphalt pavement and curb in gutter conditions experiencing some cracking & settling, appear to be in generally good condition.

Sidewalks experiencing significant cracking and chipping, appear in fair condition.

Transitions to landscape areas in ranging conditions & not clearly defined causing mulch & vegetative debris to spill onto sidewalks.

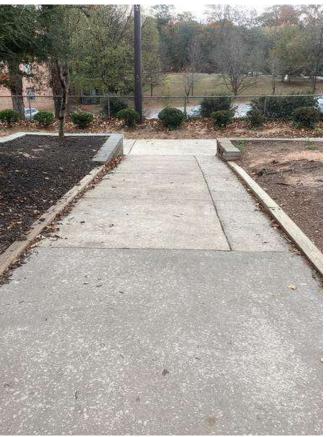
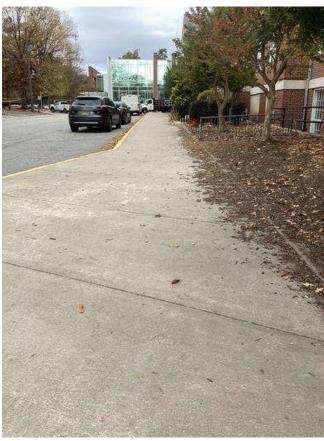
Modular wall appears damaged or loose in areas. Staining & discoloration indicates potential drainage issue.

Existing concrete sidewalks experiencing cracking and staining. Condition varies in areas ranging from good / fair conditions.

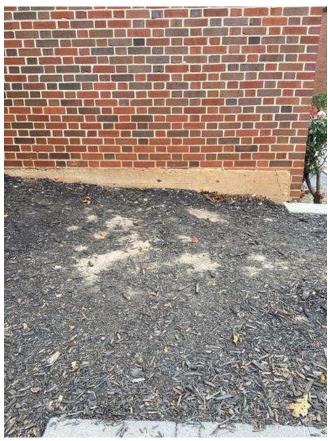
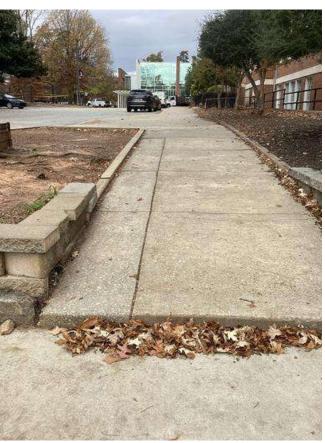
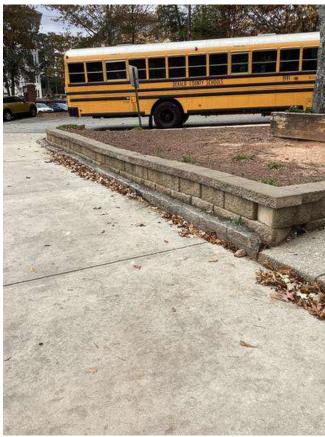
Modular wall appears damaged or loose in areas. Staining & discoloration indicates potential drainage issue.

Existing downspout boot connections in fair / poor conditions.

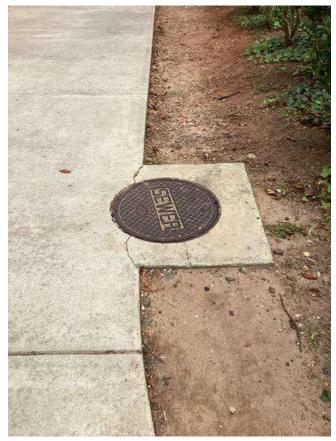
Documentation of existing utility conditions. Appears to be sanitary sewer cleanout.

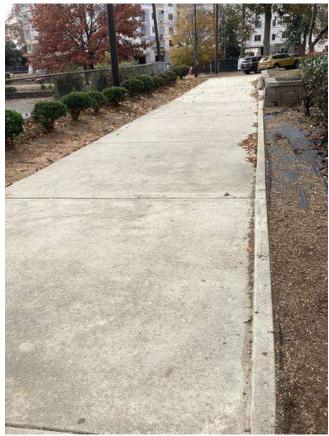
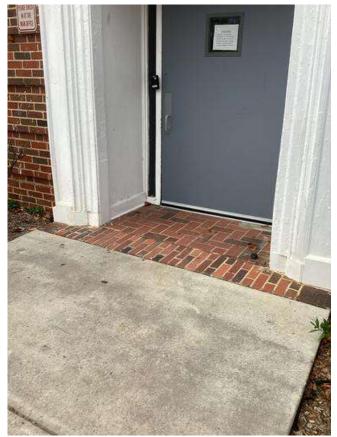
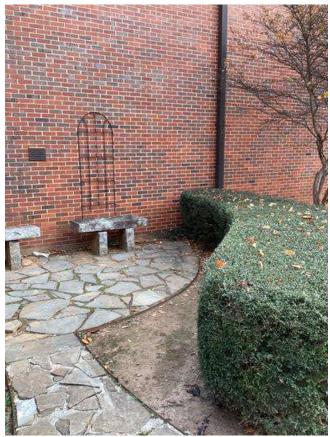
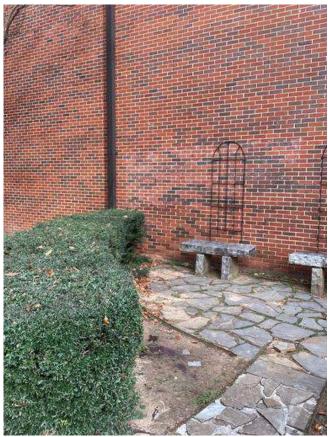
Existing concrete sidewalks experiencing cracking and staining. Condition varies in areas ranging from good / fair / poor conditions.

Existing downspout boot connections in fair / poor conditions.

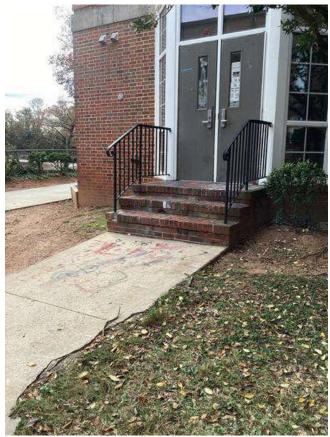
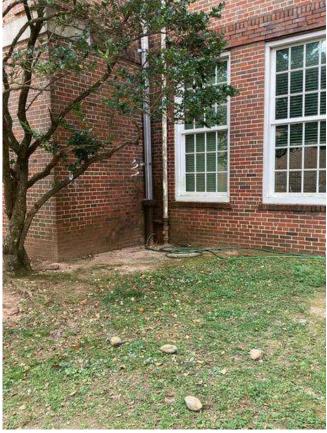
Existing concrete sidewalks experiencing cracking and staining. Condition varies in areas ranging from good / fair / poor conditions.

Existing downspout boot connections in fair / poor conditions.

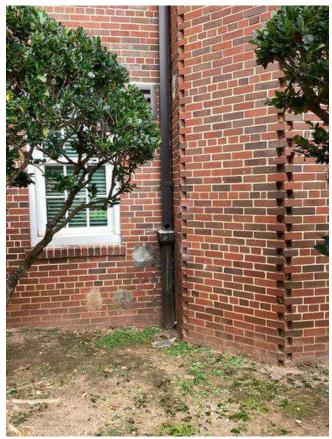
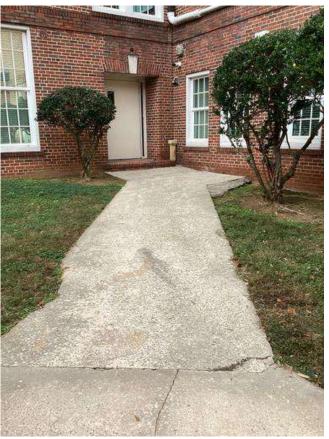
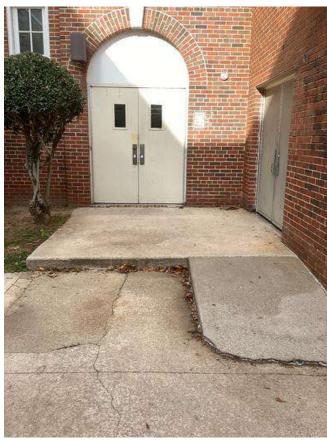
Existing concrete sidewalks experiencing cracking and staining. Condition varies in areas ranging from good / fair / poor conditions.

Existing downspout boot connections in fair / poor conditions.

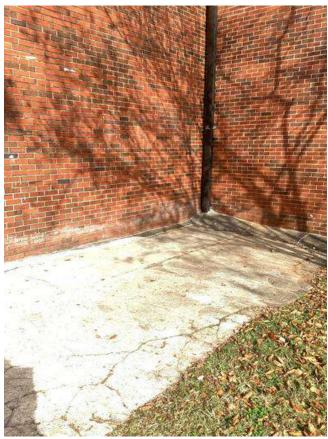
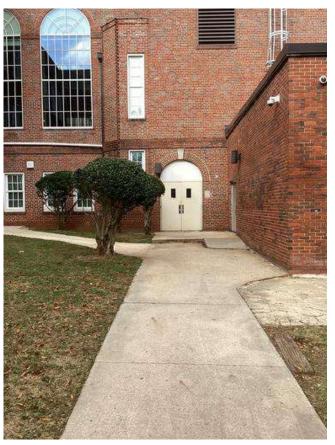
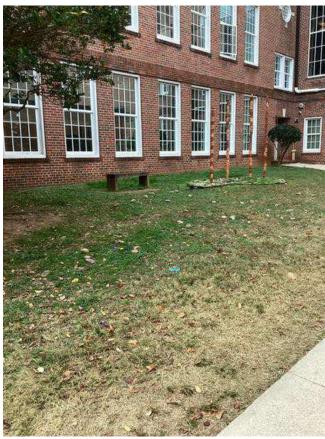
Existing concrete sidewalks & landscape wall experiencing cracking and staining. Condition varies in areas ranging from good / fair / poor conditions.

Existing downspout boot connections in fair / poor conditions.

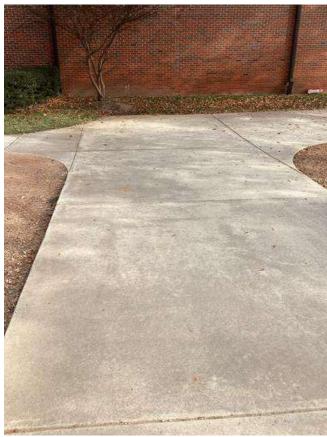
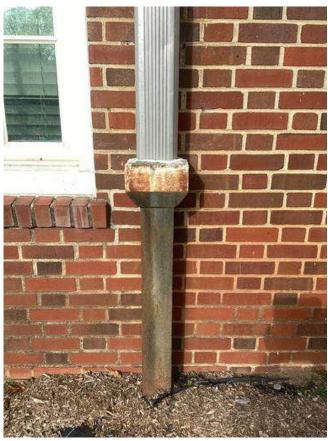
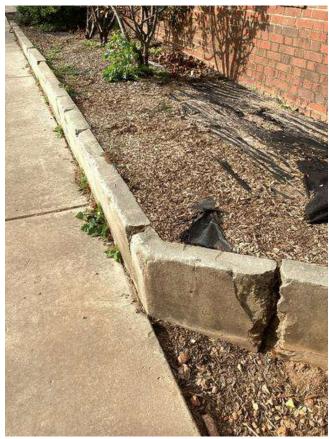
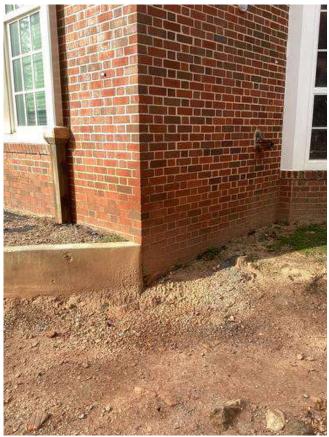
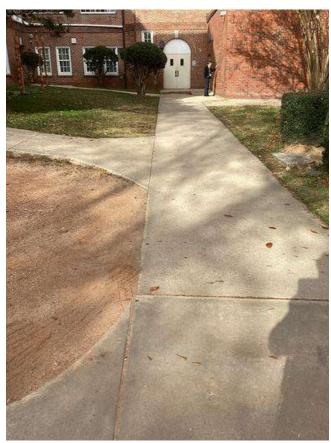
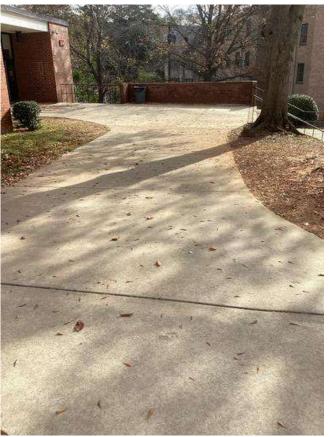
Existing downspout boot connections in fair / poor conditions.

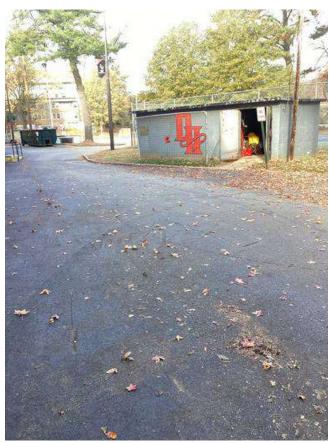
20231120_095431_photo **Cody Lanman** Nov 20, 2023 9:54 AM

Asphalt pavement conditions experiencing cracking & settling, appear to be in fair / poor condition.

Existing ramp chipped / damaged in areas.

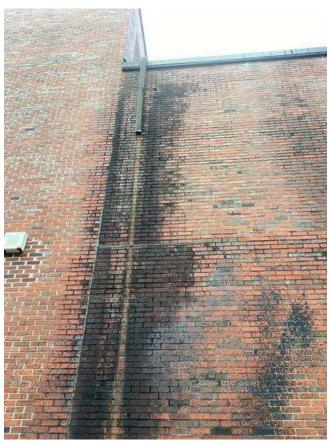
20231120_095332_photo **Cody Lanman** Nov 20, 2023 9:53 AM

Existing stairs and handrails to gymnasium are damaged & chipped.

Documentation of existing downspout locations, several boot connections appear to be missing and in poor condition.

Asphalt pavement cracking & settling, appear to be in fair / poor condition.

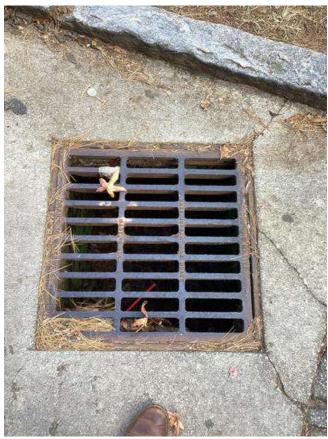
20231120_095229_photo **Cody Lanman** Nov 20, 2023 9:52 AM

Pavement surrounding drop inlet damaged and is not flush with grate and cover.

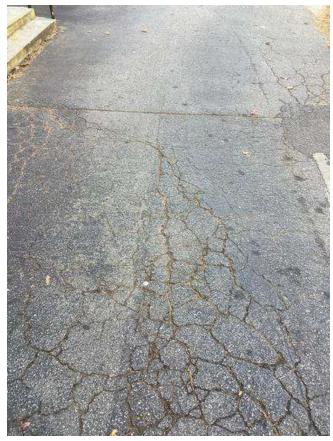
20231120_095205_photo **Cody Lanman** Nov 20, 2023 9:52 AM

Asphalt pavement conditions experiencing cracking & settling, appear to be in fair / poor condition.

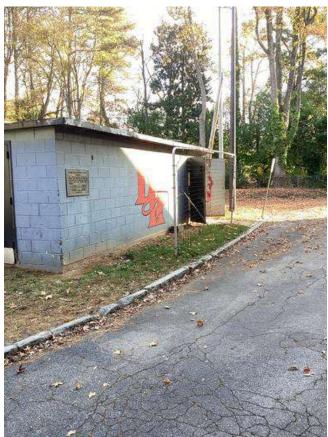
20231120_095145_photo **Cody Lanman** Nov 20, 2023 9:51 AM

Documentation of existing storage building conditions.

Asphalt pavement and curb in gutter conditions experiencing cracking & settling, appear to be in fair / poor condition.

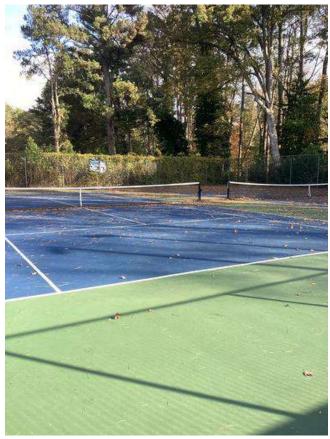
20231120_095111_photo **Cody Lanman** Nov 20, 2023 9:51 AM

Tennis Court gates and fencing damaged / warped in areas. Court surface experiencing significant staining and cracking throughout surface.

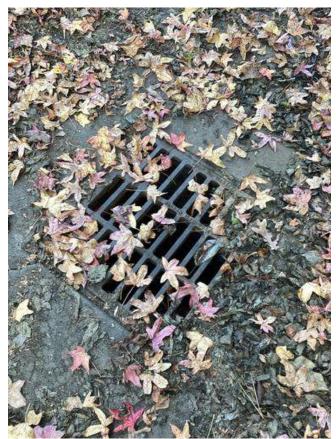
20231120_094526_photo **Cody Lanman** Nov 20, 2023 9:45 AM

Pavement surrounding drop inlet damaged and is not flush with grate cover. Inlet and structure appear to be full of trash and debris.

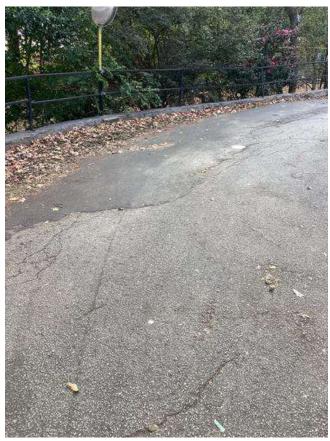
20231120_094456_photo Cody Lanman Nov 20, 2023 9:44 AM

Documentation of existing downspout locations, several boot connections appear to be in poor condition.

Asphalt pavement cracking & settling, appear to be in fair / poor condition. Asphalt patch / repair locations appear in poor condition and experiencing pumping causing low points along top of retaining wall.

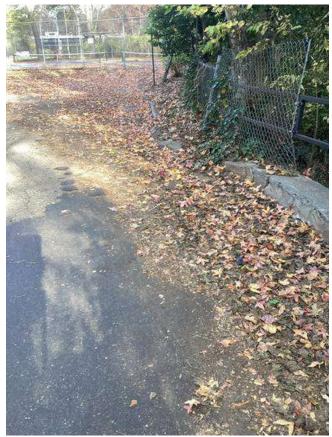
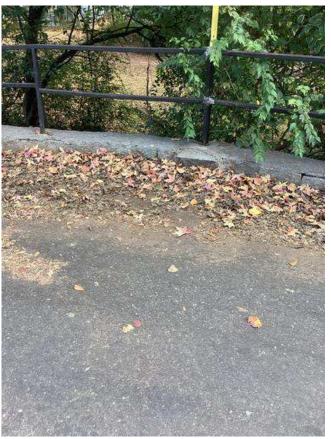
Existing fencing appears damaged in areas.

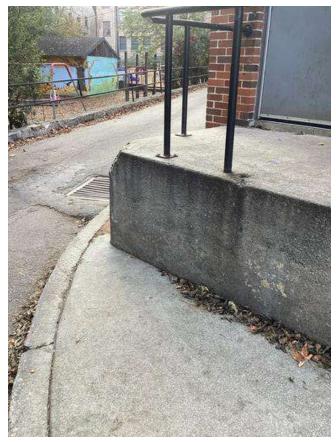
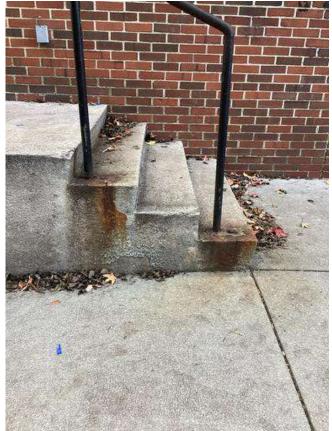
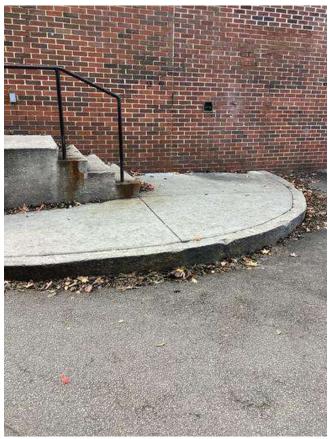
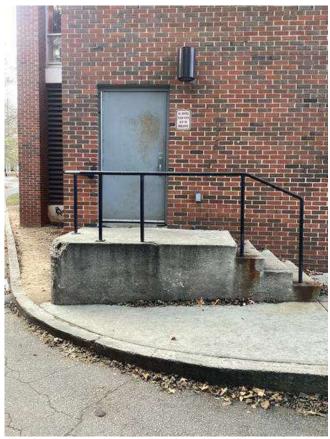
Existing stairs and handrails to gymnasium are damaged & chipped. Curbing around landing area appears higher than typical.

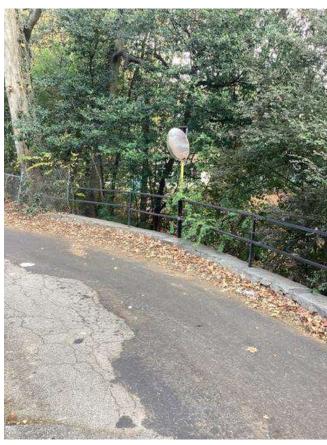
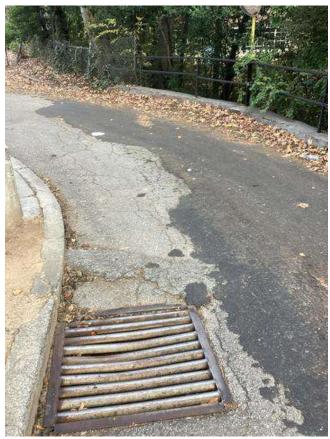
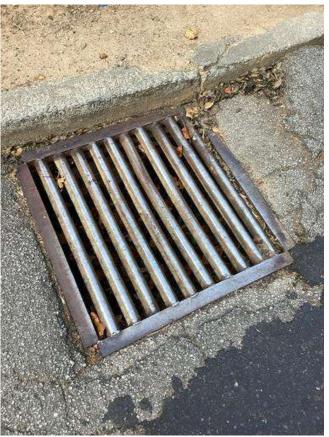
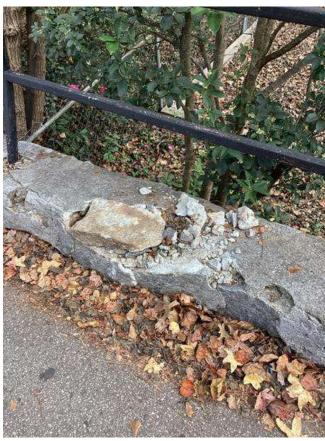
Pavement surrounding drop inlet damaged and is not flush with grate cover. Inlet and structure appear to be full of trash and debris.

Asphalt pavement and curb in gutter conditions experiencing cracking & settling, appear to be in fair / poor condition.

Driveway width does not appear to adhere to recommended layout or adhere to aerial apparatus fire code requirements.

Existing retaining wall and handrails are damaged. Note: Majority of access drive and wall are over property line, encroachment is identified on existing easement agreements with adjacent property owner.

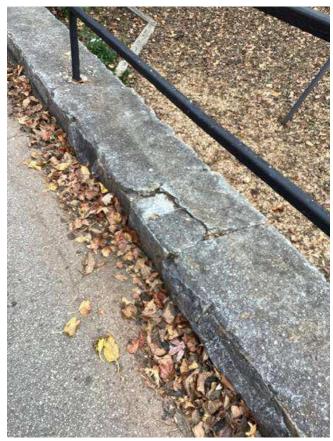
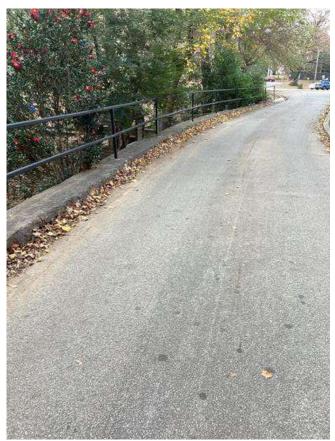
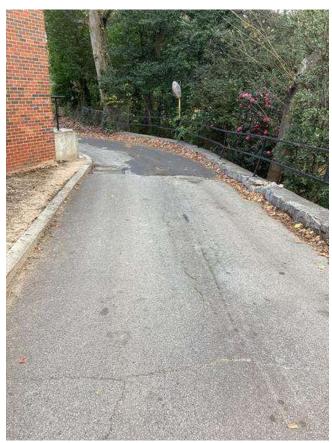
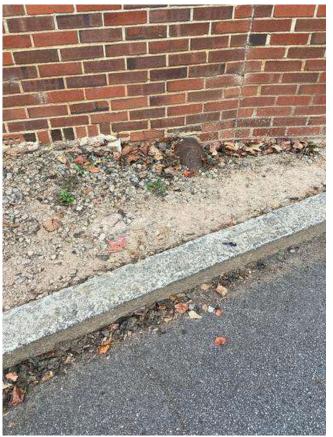
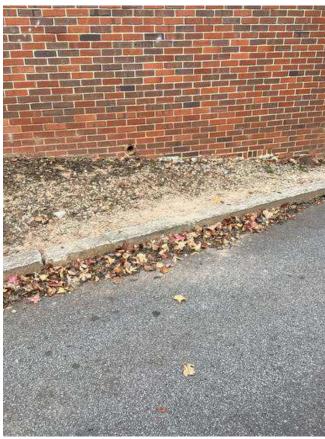
Asphalt pavement and curb in gutter conditions experiencing cracking & settling, appear to be in fair / poor condition.

Driveway width does not appear to adhere to recommended layout or adhere to aerial apparatus fire code requirements.

Existing retaining wall and handrails are damaged. Note: Majority of access drive and wall are over property line, encroachment is identified on existing easement agreements with adjacent property owner.

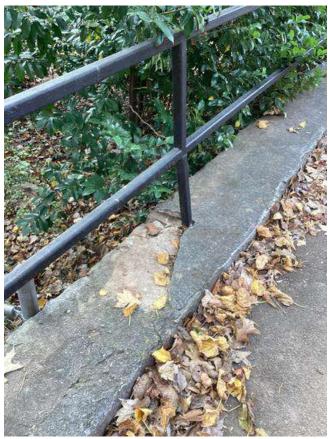
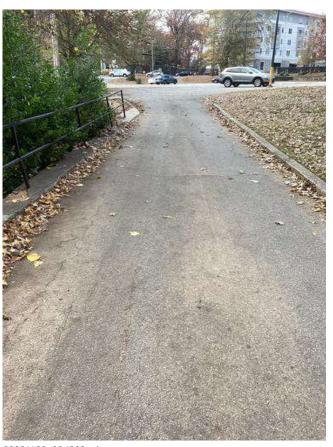
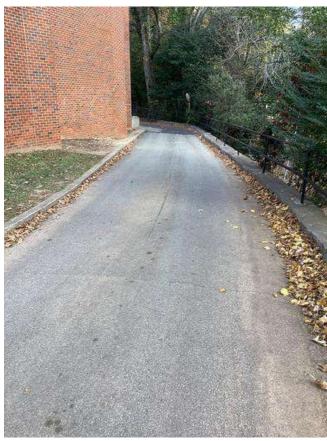
Asphalt pavement and curb in gutter conditions experiencing cracking & settling, appear to be in fair / poor condition.

Driveway width does not appear to adhere to recommended layout or adhere to aerial apparatus fire code requirements.

Existing retaining wall and handrails are damaged. Note: Majority of access drive and wall are over property line, encroachment is identified on existing easement agreements with adjacent property owner.

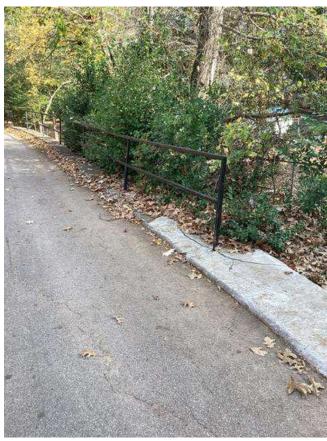
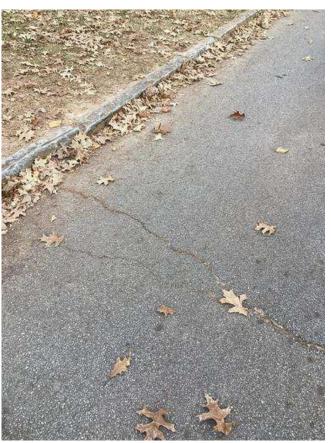
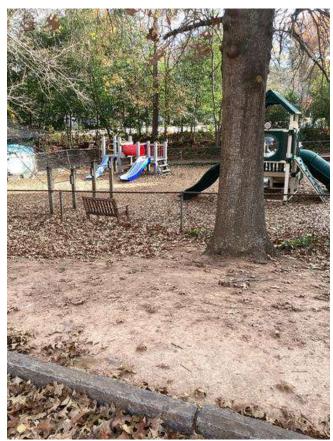
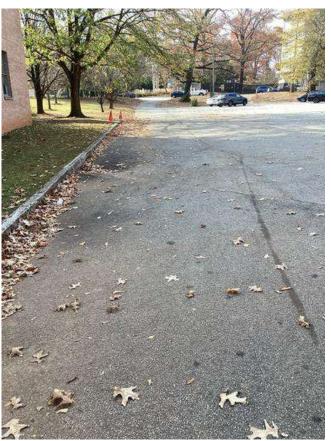
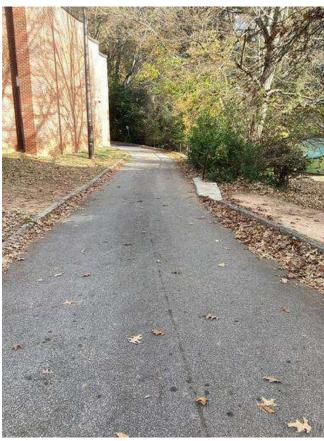
Asphalt pavement and curb in gutter conditions experiencing cracking & settling, appear to be in fair / poor condition.

Driveway width does not appear to adhere to recommended layout or adhere to aerial apparatus fire code requirements.

Existing retaining wall and handrails are damaged. Note: Majority of access drive and wall are over property line, encroachment is identified on existing easement agreements with adjacent property owner.

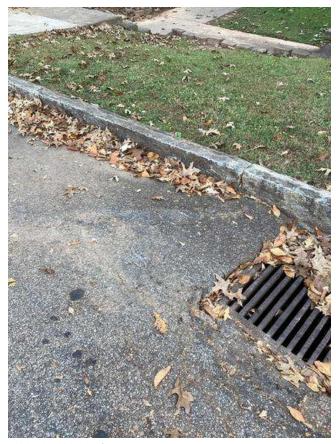
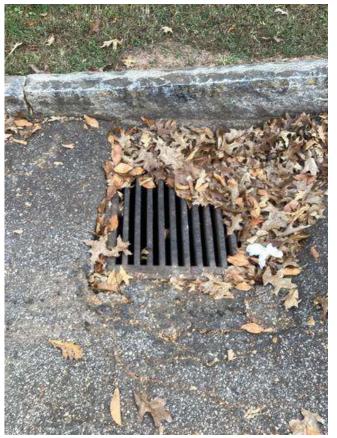
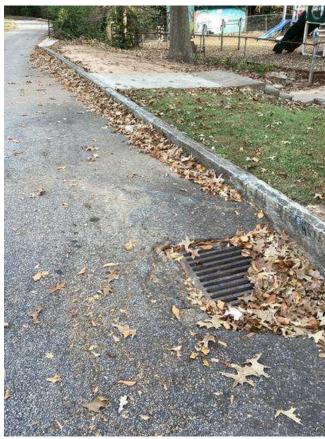
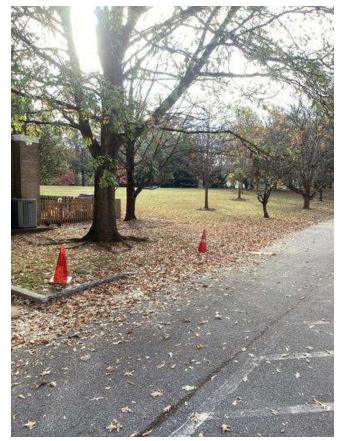
Pavement surrounding drop inlet damaged and is not flush with grate cover. Inlet and structure appear to be full of trash and debris.
