Dekalb County School District (409-36) - Druid Hills High School Modernization Civil Site Assessment

Prepared by Cody Lanman Jan 31, 2024

Druid Hills Highschool Modernization Assessment, Preliminary Civil Site Investigation & observations. The following report documents the existing conditions of the DHHS Campus as it relates to the civil / site considerations.

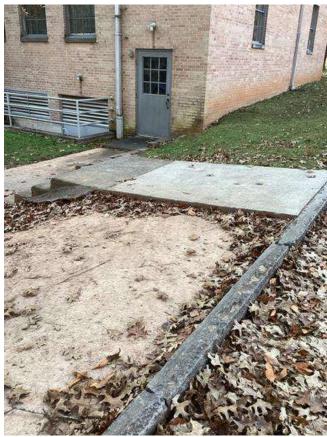
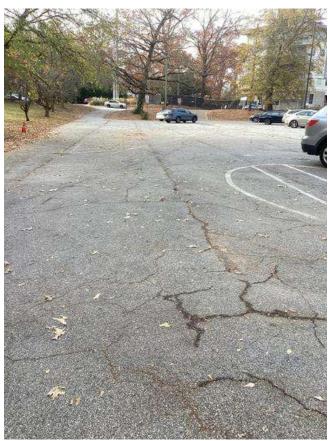
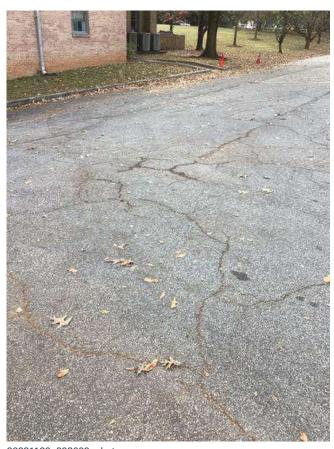
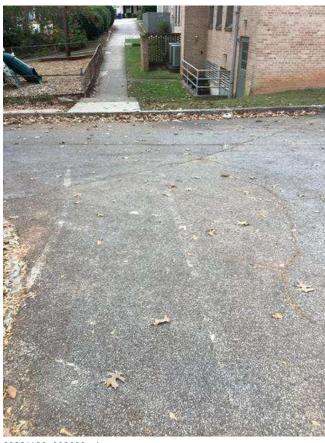
Asphalt pavement and curb in gutter conditions experiencing cracking & settling, appear to be in fair / poor condition.

Lot layout and dimensions do not appear to adhere to recommended layout or code requirements.

Striping is faded or missing in areas.

Existing light pole base appears damaged.

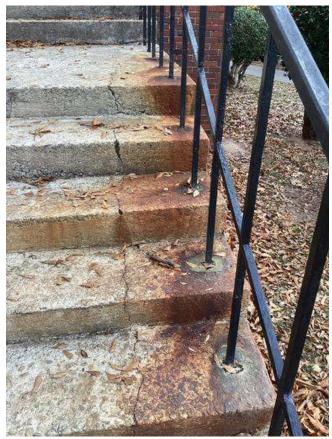
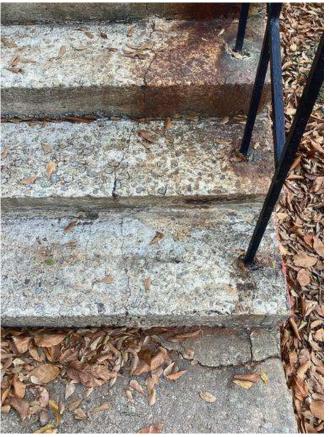
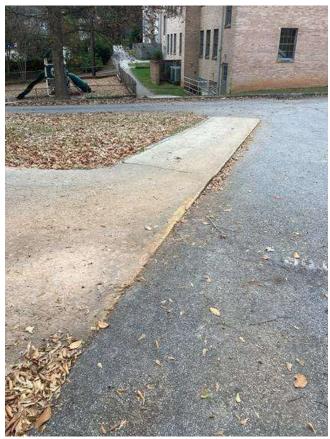
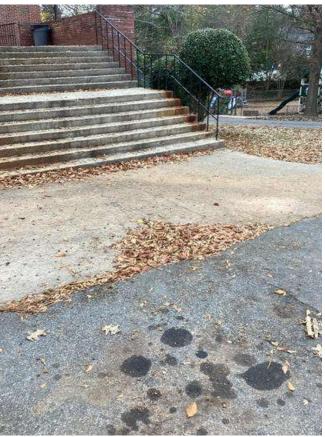
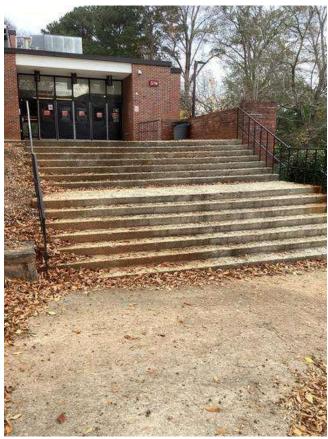
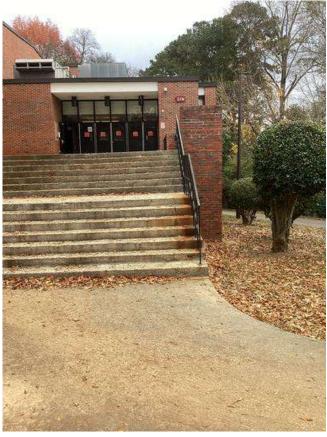
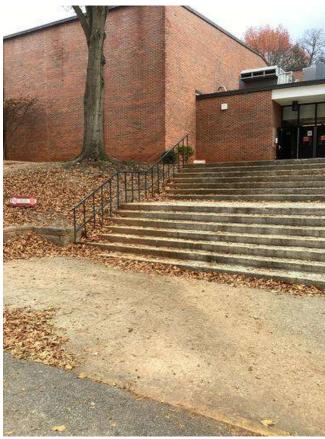
Existing sidewalk and stairs experiencing cracking and appear to be in fair / poor condition.

Sidewalk and pavement transition uneven in areas posing possible tripping hazard. Significant staining occurring at drop off area.

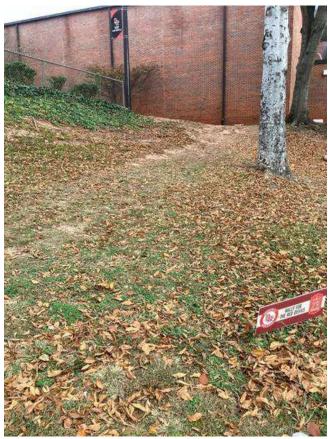
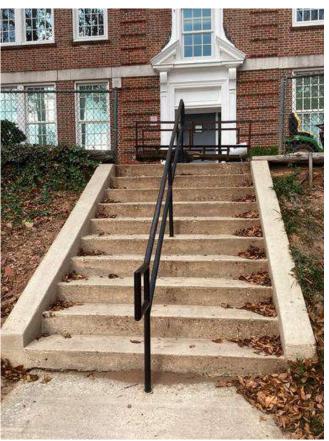
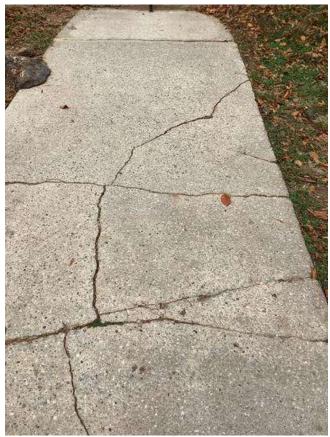
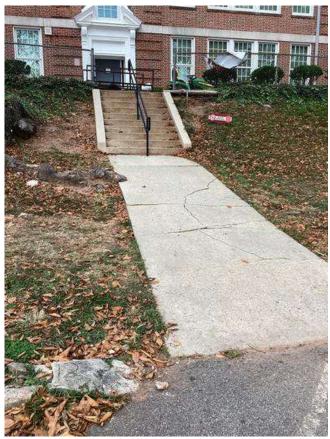
Existing sidewalk and stairs experiencing cracking and appear to be in fair condition. Stair handrails do not appear to adhere to standard configuration.

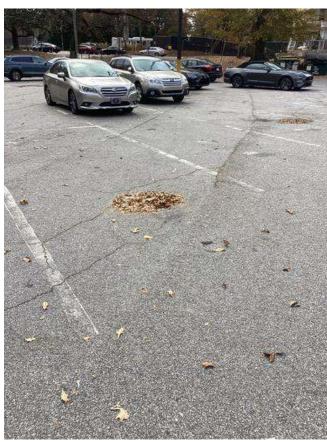
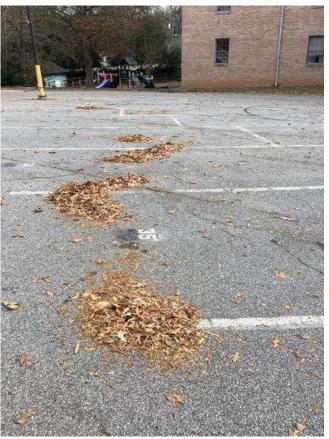
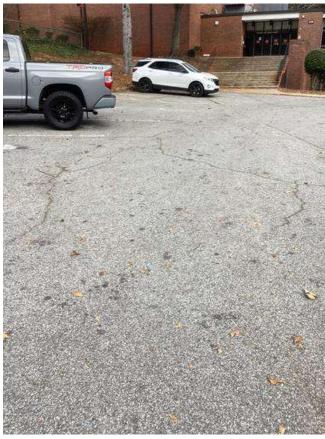
Asphalt pavement and curb in gutter conditions experiencing cracking & settling, appear to be in fair / poor condition.

Lot layout and dimensions do not appear to adhere to recommended layout or code requirements.

Striping is faded or missing in areas.

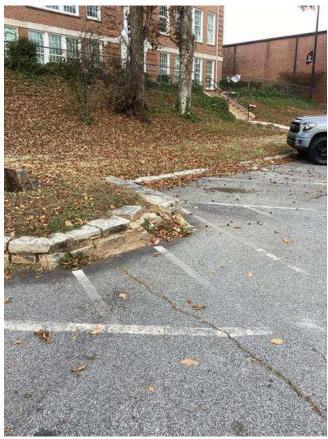
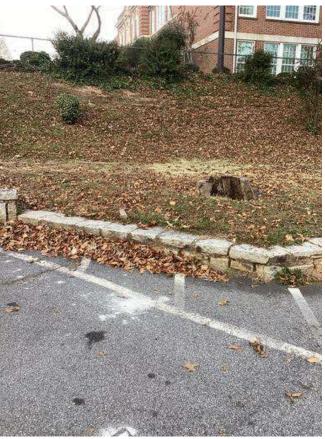
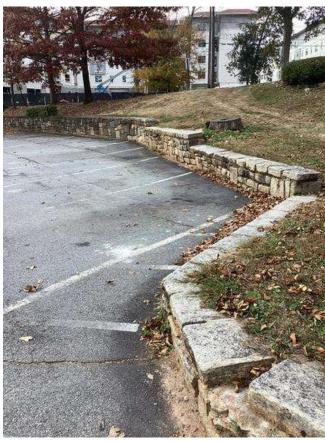
Asphalt pavement and curb in gutter conditions experiencing cracking & settling, appear to be in fair / poor condition.

Lot layout and dimensions do not appear to adhere to recommended layout or code requirements.

Striping is faded or missing in areas.

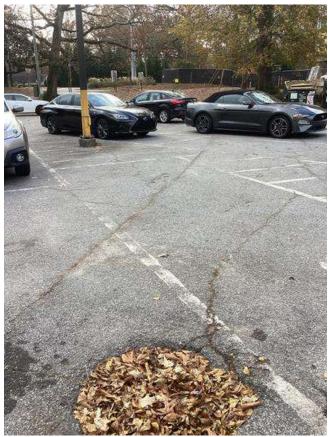
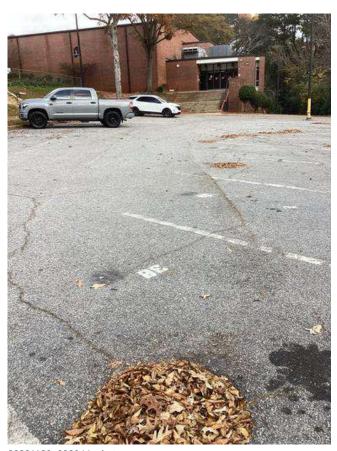
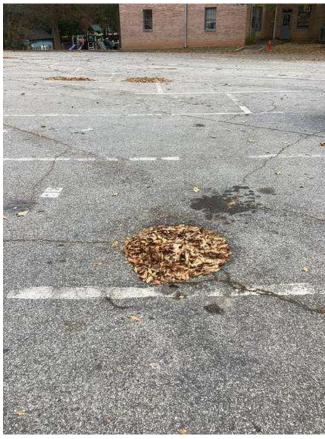
Asphalt pavement and curb in gutter conditions experiencing cracking & settling, appear to be in fair / poor condition.

Lot layout and dimensions do not appear to adhere to recommended layout or code requirements.

Striping is faded or missing in areas.

Existing Sewer Manhole. Pavement surrounding drop inlet damaged and is not flush with cover.

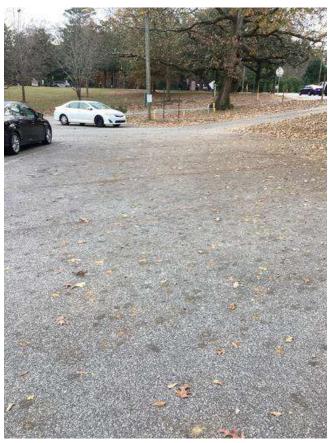
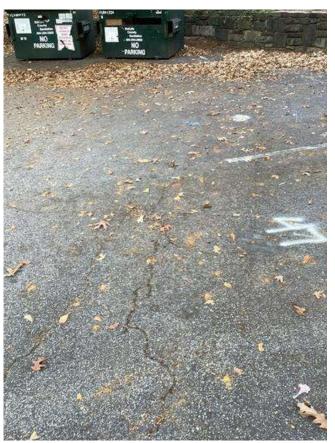
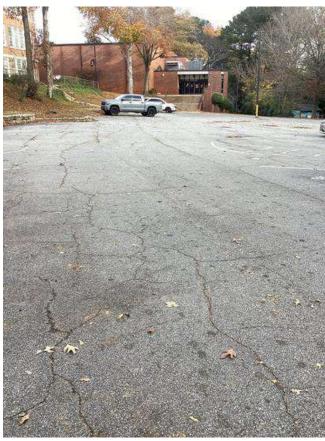
Asphalt pavement and curb in gutter conditions experiencing cracking & settling, appear to be in fair / poor condition.

Lot layout and dimensions do not appear to adhere to recommended layout or code requirements.

Striping is faded or missing in areas.

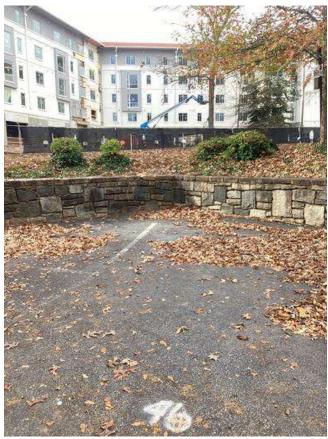
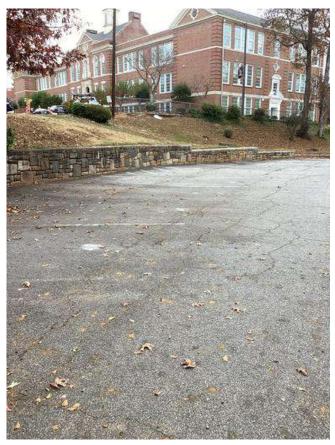
Asphalt pavement and curb in gutter conditions experiencing cracking & settling, appear to be in fair / poor condition.

Lot layout and dimensions do not appear to adhere to recommended layout or code requirements.

Striping is faded or missing in areas.

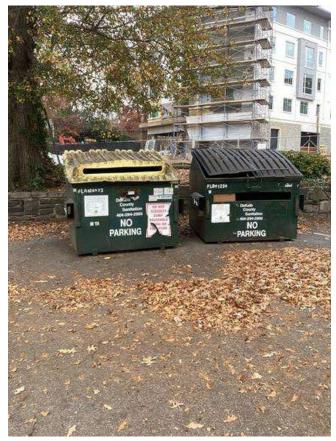
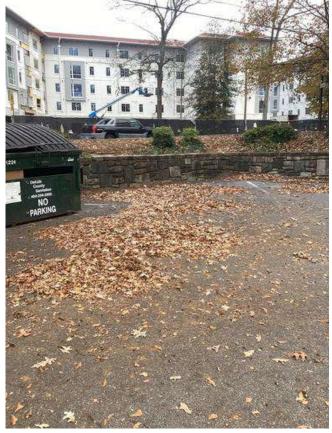
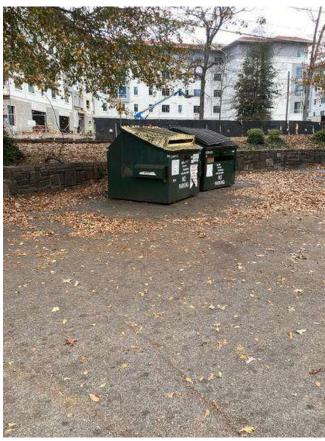
Dumpster and recycling bin. Pavement around dumpsters appears damaged. No protection / approach pad provided at dumpster locations.

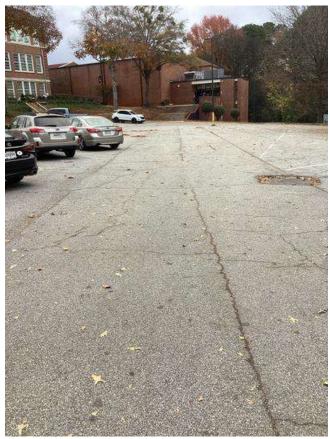
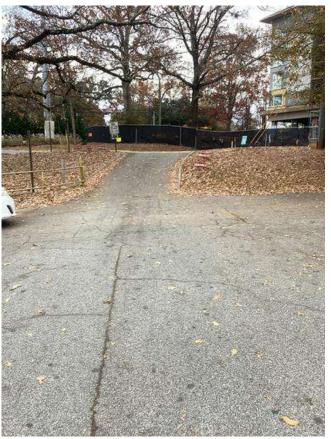
Asphalt pavement and curb in gutter conditions experiencing cracking & settling, appear to be in fair / poor condition.

Lot layout and dimensions do not appear to adhere to recommended layout or code requirements.

Striping is faded or missing in areas.

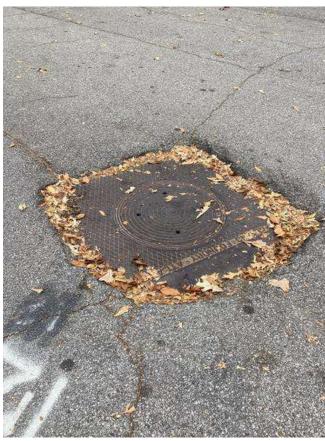
Existing Storm Junction Box. Pavement surrounding drop inlet damaged and is not flush with cover.

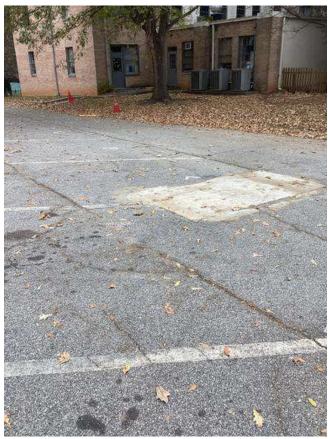
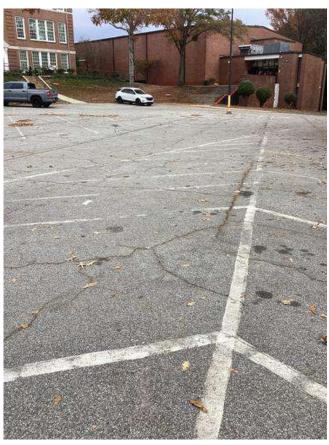
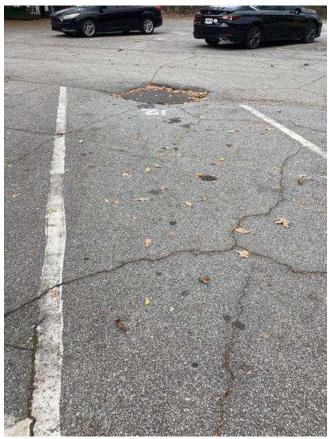
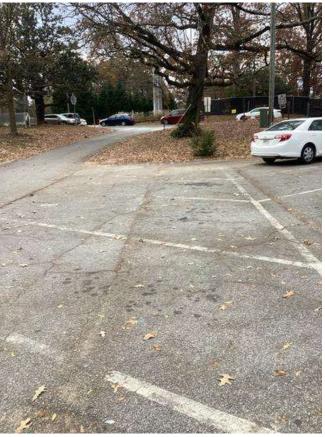
Asphalt pavement and curb in gutter conditions experiencing cracking & settling, appear to be in fair / poor condition.

Lot layout and dimensions do not appear to adhere to recommended layout or code requirements.

Striping is faded or missing in areas.

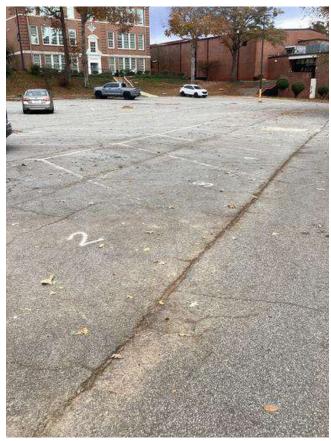
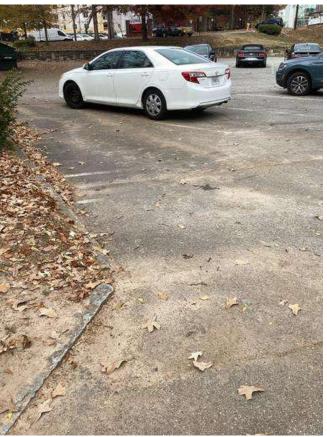
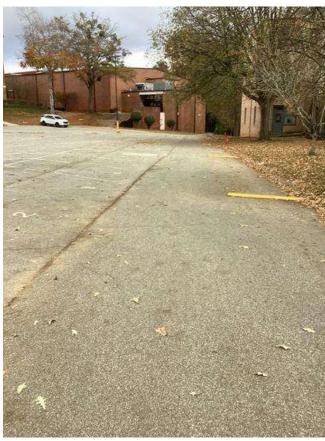
Asphalt pavement and curb in gutter conditions experiencing cracking & settling, appear to be in good / fair / poor condition.

Striping is faded or missing in areas.

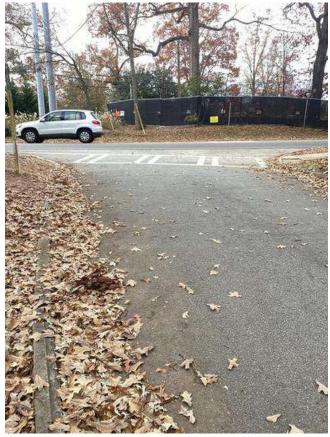
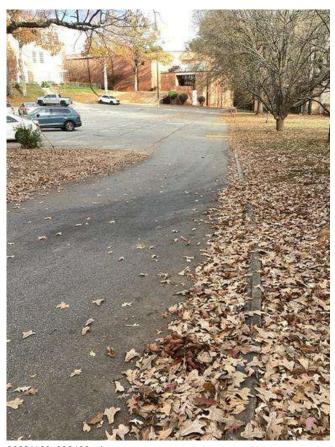
Asphalt driveway experiencing some cracking & settling, appear to be in good / fair condition.

Driveway width and slopes does not appear to adhere to standard recommendations and does not appear to meet code dimensions.

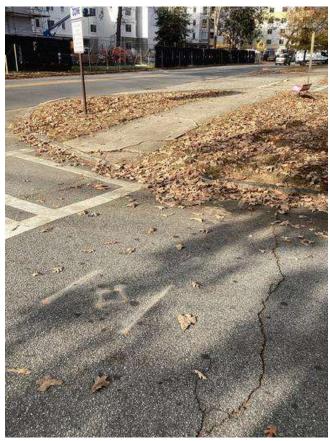
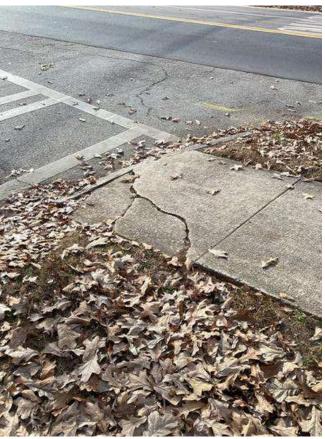
Asphalt driveway and curb in gutter conditions experiencing some cracking & settling, appear to be in good / fair condition.

Sidewalks experiencing some cracking and chipping, appear in fair condition.

Driveway configuration and connection to right-of-way not does not appear to adhere to standard recommendations and does not appear to meet code dimensions.

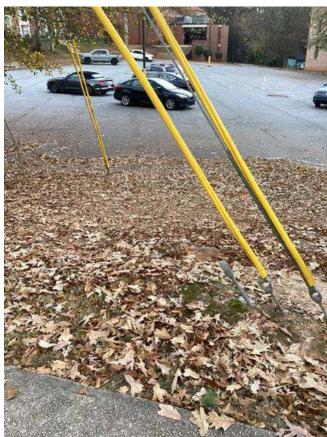
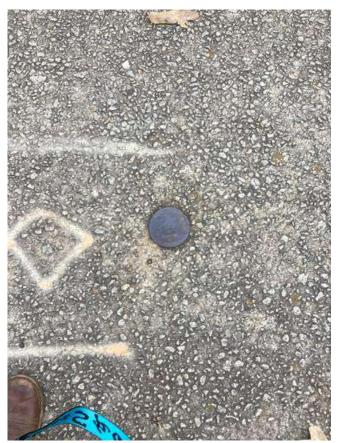
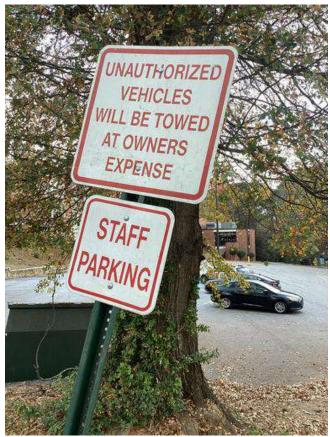
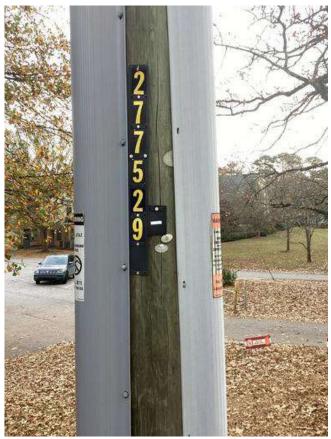
Signage damaged / falling.

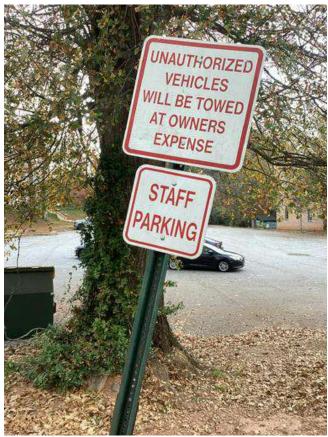
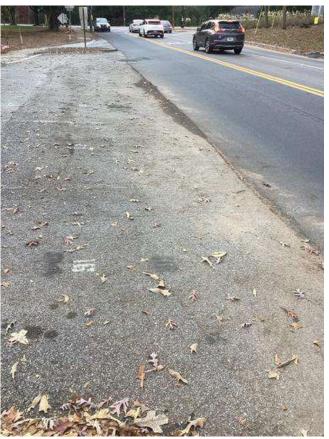
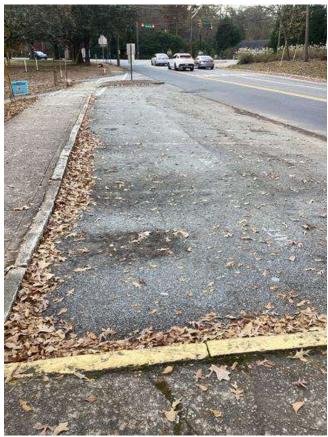
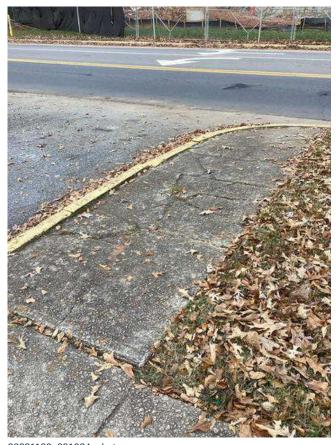
Asphalt pavement and curb in gutter conditions experiencing some cracking & settling, appear to be in generally good condition. Parking striping very faded.

Sidewalks experiencing significant cracking and chipping, appear in fair condition.

Existing signage damaged & very close the sidewalk and curb.

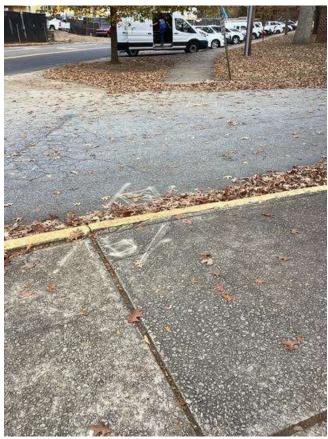
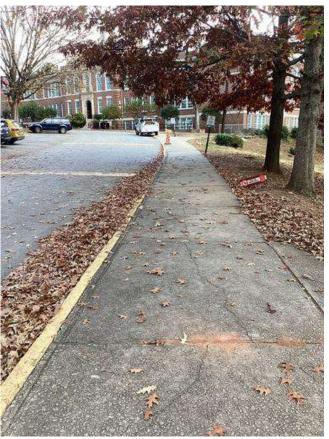
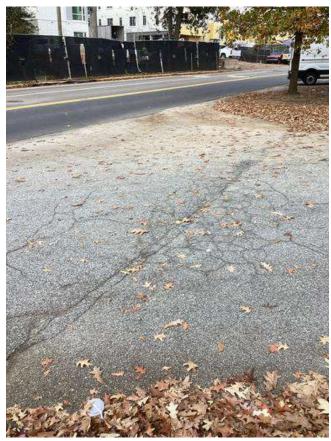
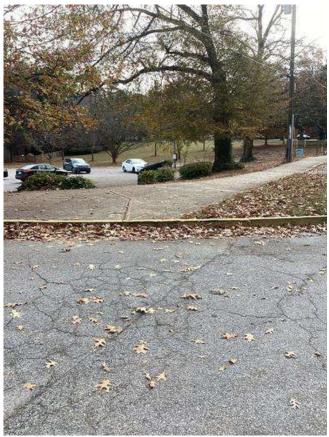
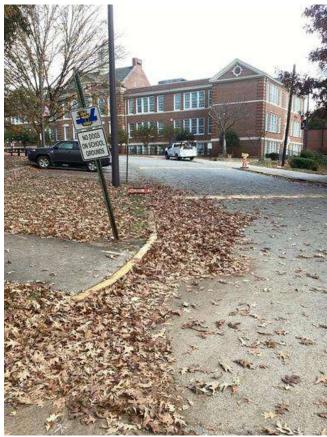
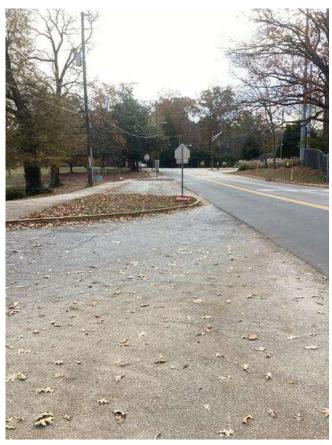
Observations & conditions of existing entrance drop off driveway.

Asphalt driveway and curb in gutter conditions experiencing some cracking & settling, appear to be in generally good condition.

Sidewalks experiencing some cracking and chipping, appear in good to fair condition.

Existing signage damaged & very close the sidewalk and curb.
