## **Revision Date - 09/24/2021**

# **FACILITY CONDITION ASSESSMENT**

Dresden Elementary School | 2021

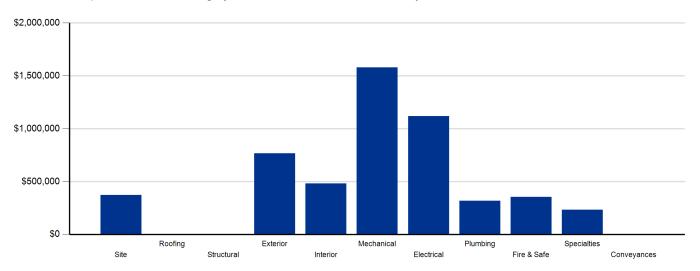
Figure 2: System Deficiencies

The chart below represents the building systems and associated deficiency costs.
